Sam Preuss	9-16-2022
<i>Name of Client</i>	<i>Date of Inspection</i>
550 Co Rd 221, Cameron, TX 76520	
<i>Address of Inspected Property</i>	
Gary Mohel	TREC #4211
<i>Name of Inspector</i>	<i>TREC License #</i>
<i>Name of Sponsor (if applicable)</i>	<i>TREC License #</i>

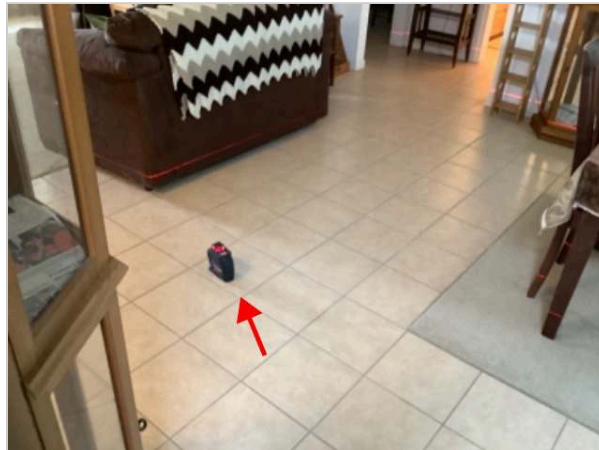
Floor levels taken with a laser level appeared to be within normal tolerances overall, however they did slope from back to front and from right to left. The slab on grade foundation appeared to be performing at the time of the inspection. The Central Texas area has clay soil that shrinks and swells with variations in the moisture content, which can cause movement to the foundation. A constant moisture content should be kept in the soil around the foundation to reduce movement. We are not structural engineers and this inspection can't determine if there will be future movement.

Floor levels taken

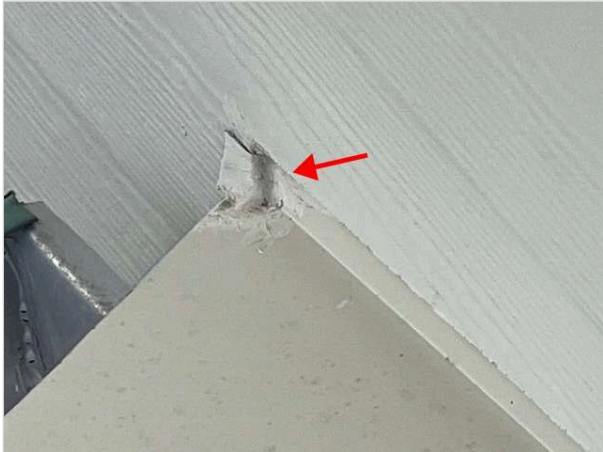
Flashing details weren't visible. The only way to tell if a metal roof is watertight is to observe during a rain. The metal roofing did not have typical kickout flashing where the roof terminated along an upper wall. There was a small section of flashing to divert water from the opening in the wall.

Flashing diverts water

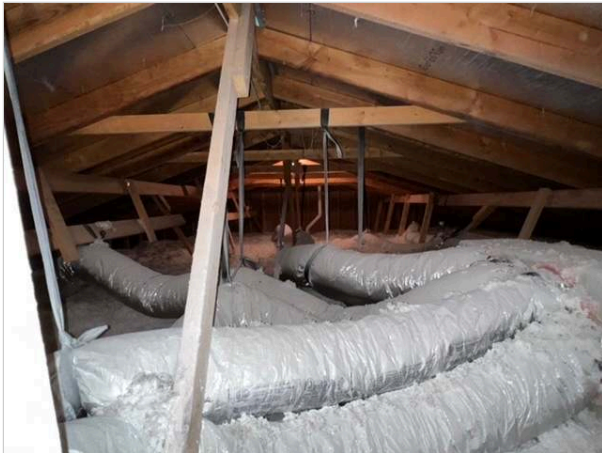
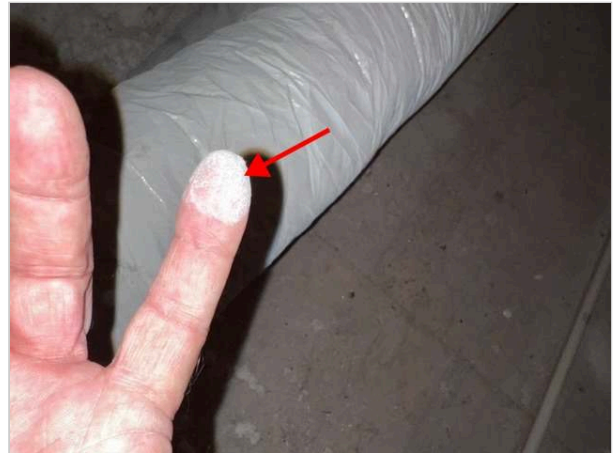
Residue in attic

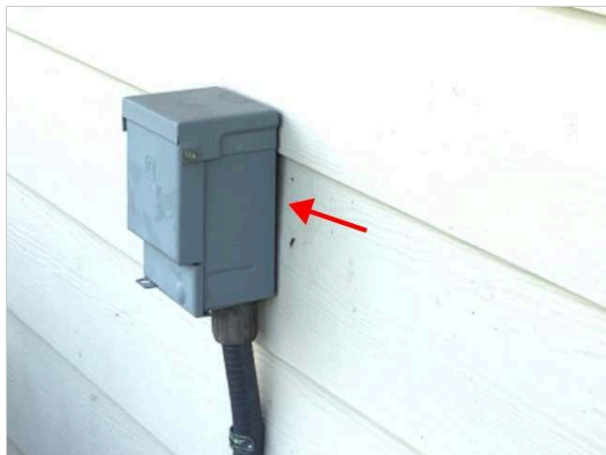
There were gaps at siding joints, which require caulk to prevent water intrusion. Exterior walls were not caulked around light fixtures and the electrical disconnect for the AC. There were gaps in the siding around penetrations in back. There was no flashing along the top of the windows. The upper trim was caulked however and the front and right windows were

Not caulked

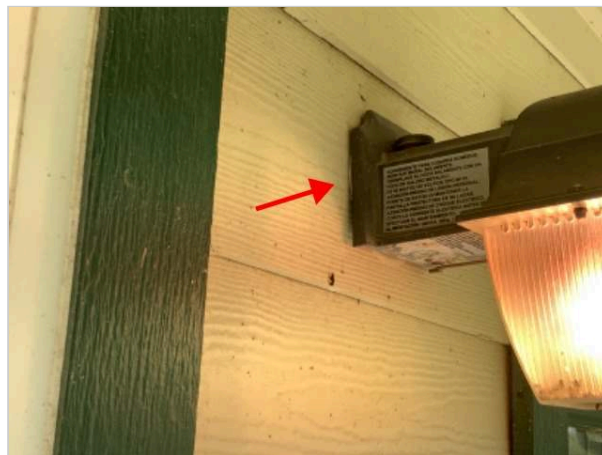
Not caulked

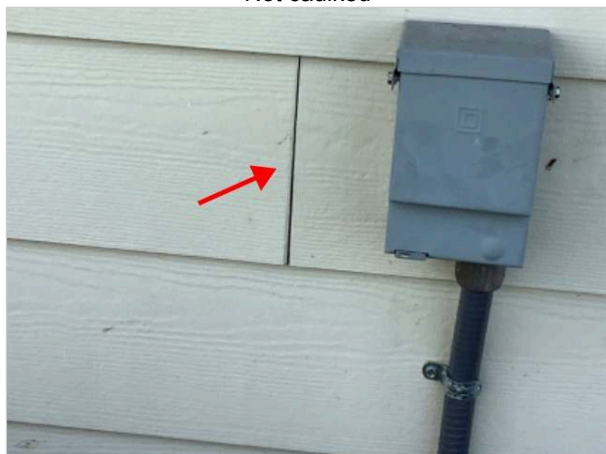
Gaps

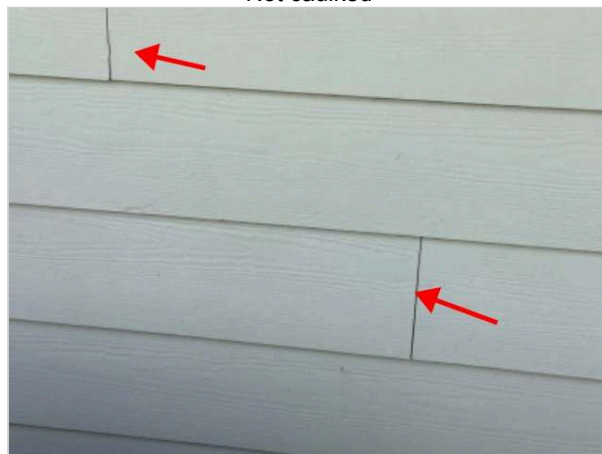
Gaps

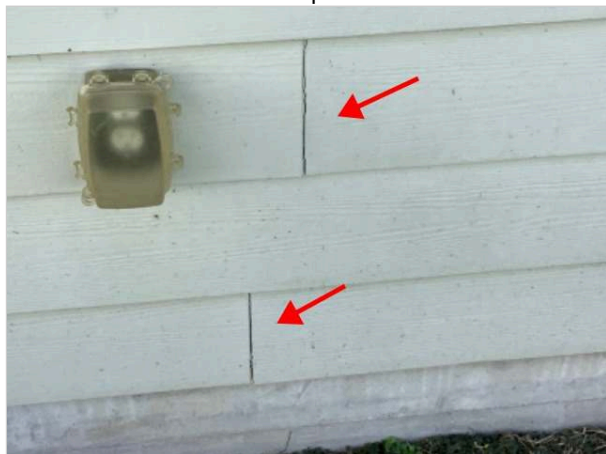
Gaps

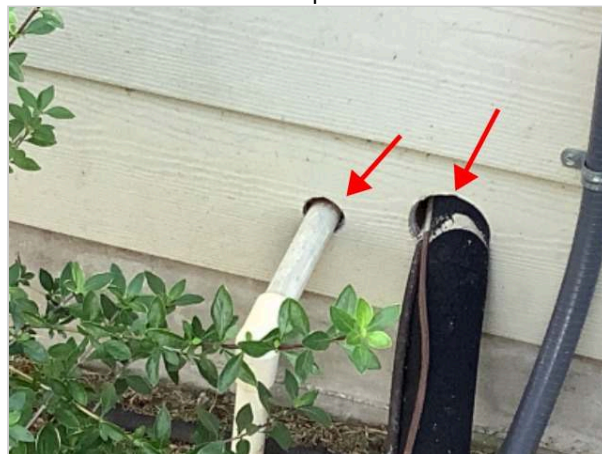
Gaps

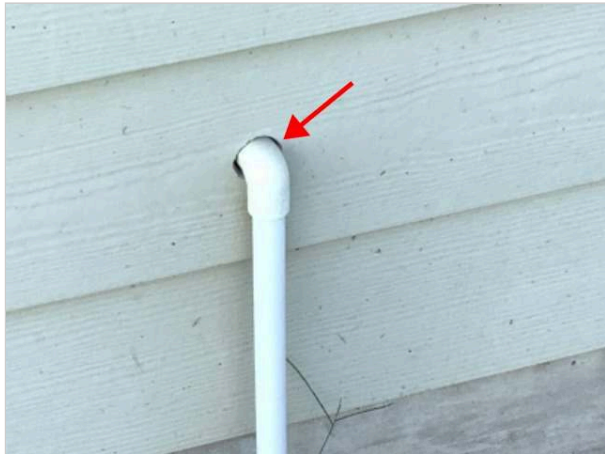
Gaps

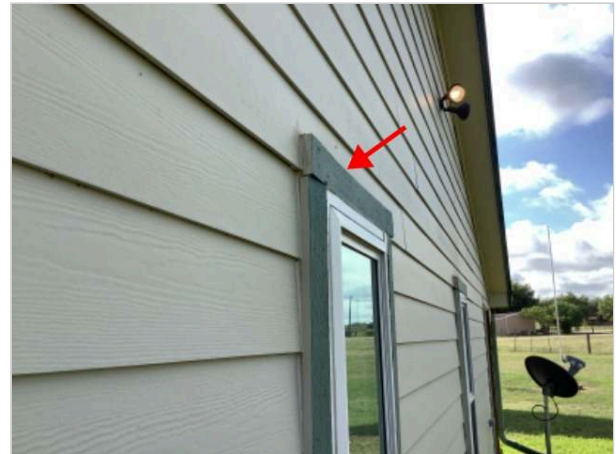
No flashing

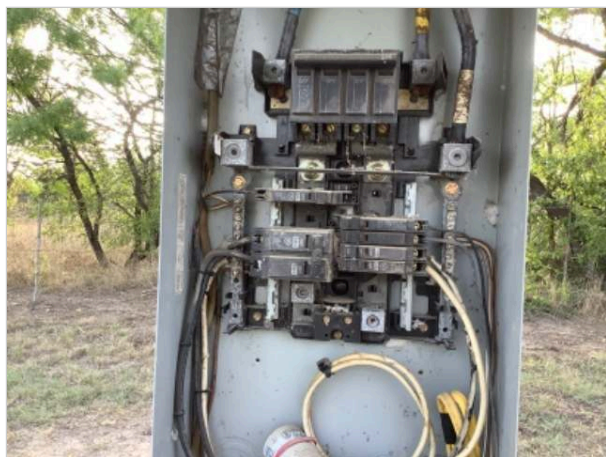
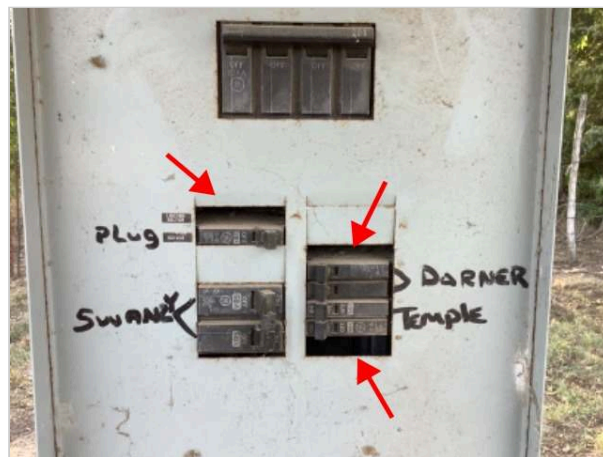
*Deficiencies:*  
Utility pole entrance panel: Breaker knocks were open in the panel. There was a 30 amp breaker in the panel with #12 wire. Number 12 wire is normally served by a 20 amp breaker although there are exceptions. There were multiple wires inserted into the same hole on the neutral bus bar in the panel, a common practice but not per NEC standards. Neutral wires should be in a hole by themselves. Two securing screws were missing for the inside cover of the entrance panel on the garage wall. One or more white sheathed wires were not marked as hot at connections to breakers in both entrance panels and in both sub panels, which today's standard requires. A breaker knockout was open in the garage sub panel.

Knockouts open

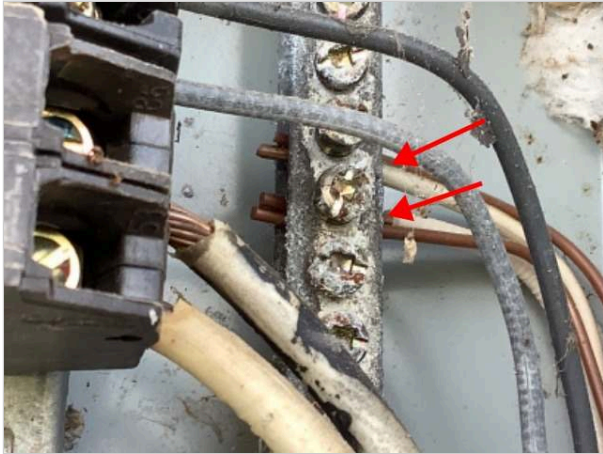
Multiple wires in holes

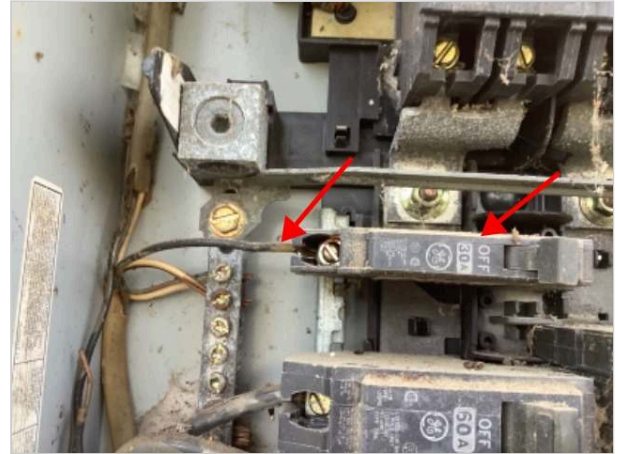
30 amp breaker with #12 wire

- Utility pole entrance panel: Breaker knocks were open in the panel. There was a 30 amp breaker in the panel with #12 wire. Number 12 wire is normally served by a 20 amp breaker although there are exceptions. There were multiple wires inserted into the same hole on the neutral bus bar in the panel, a common practice but not per NEC standards. Neutral wires should be in a hole by themselves.
- Two securing screws were missing for the inside cover of the entrance panel on the garage wall.
- One or more white sheathed wires were not marked as hot at connections to breakers in both entrance panels and in both sub panels, which today's standard requires.
- A breaker knockout was open in the garage sub panel.

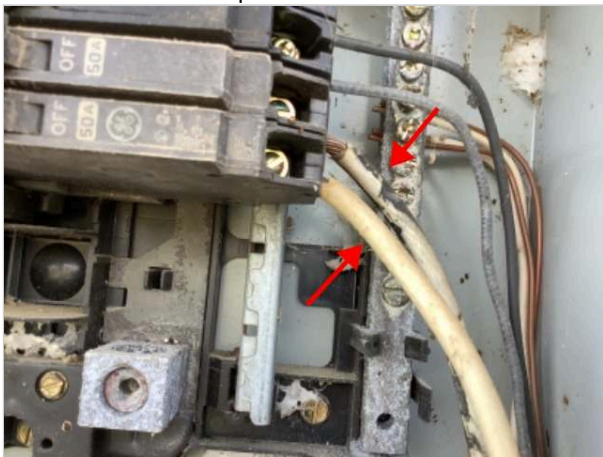
Not marked hot

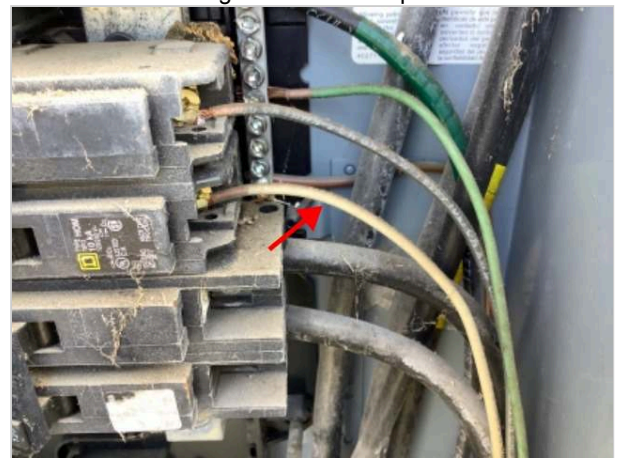
Not marked hot

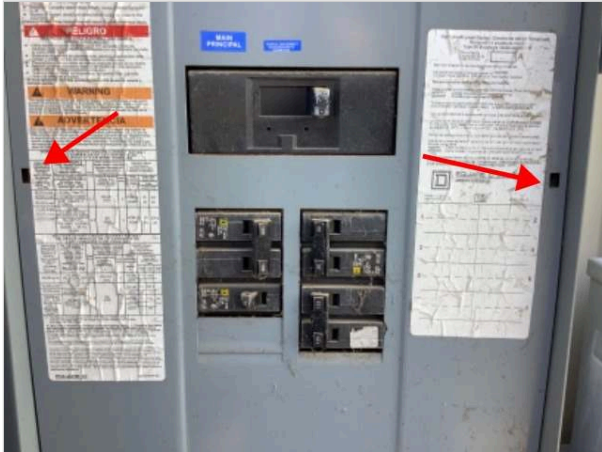
Screws missing

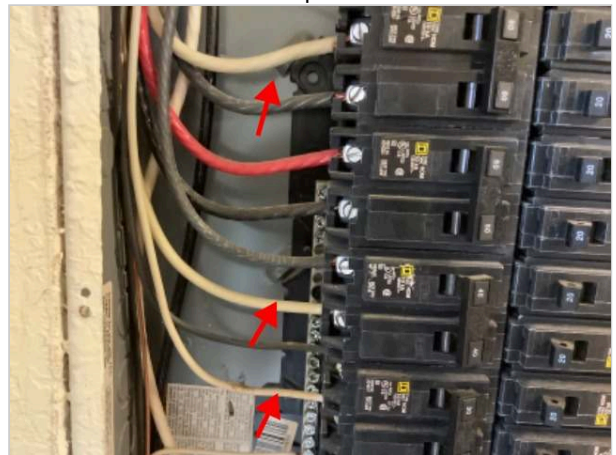
Not marked hot

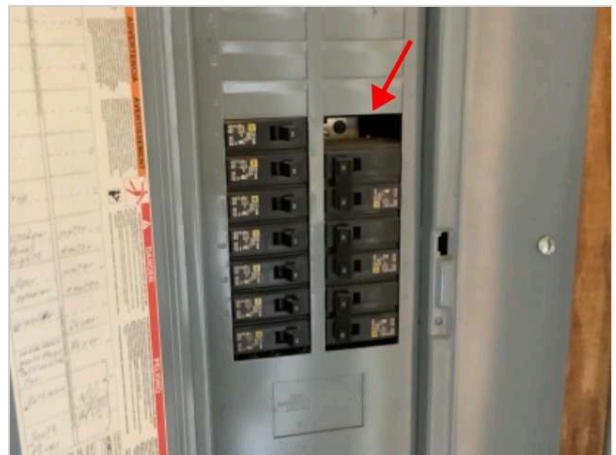
Knockout open

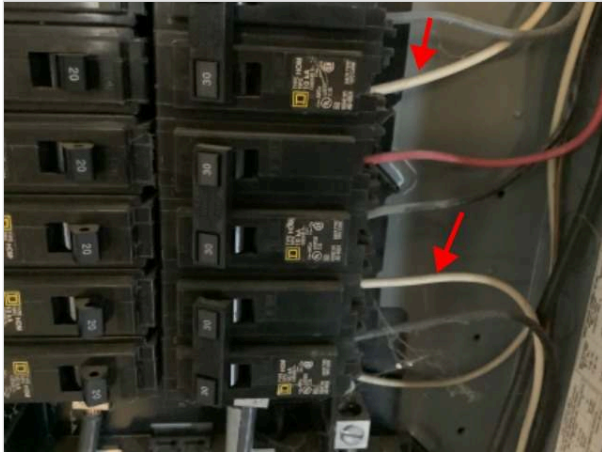
Not marked hot

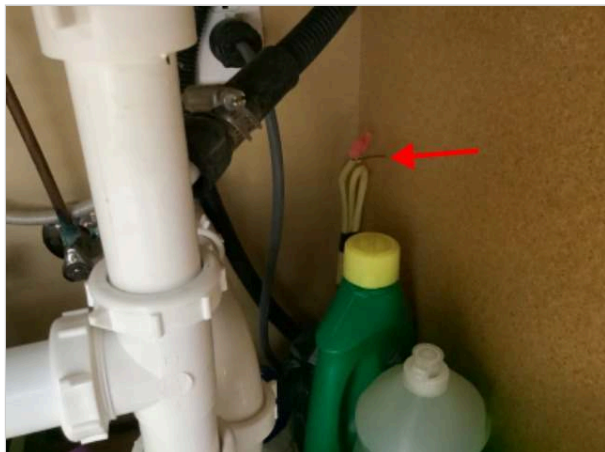
Capped wire

- There was a loose capped wire in the cabinet under the kitchen sink. It did not test hot but should be properly terminated in a junction box.
- The ground wire was not connected to random switches checked, a common practice on older homes but not per NEC standards.

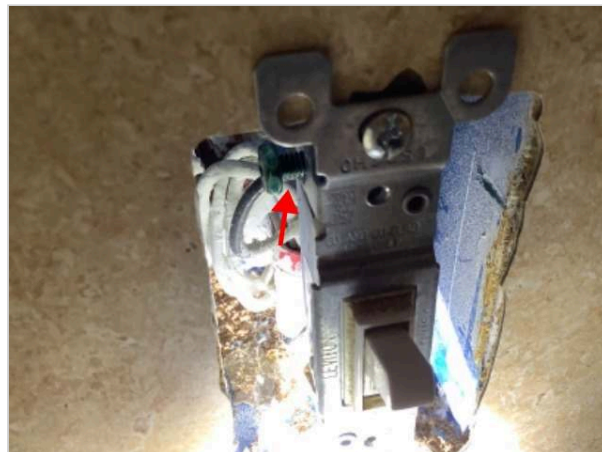
No ground wire

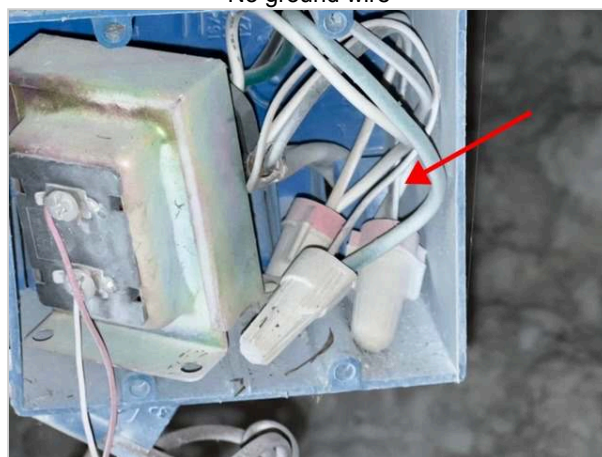
Box uncovered

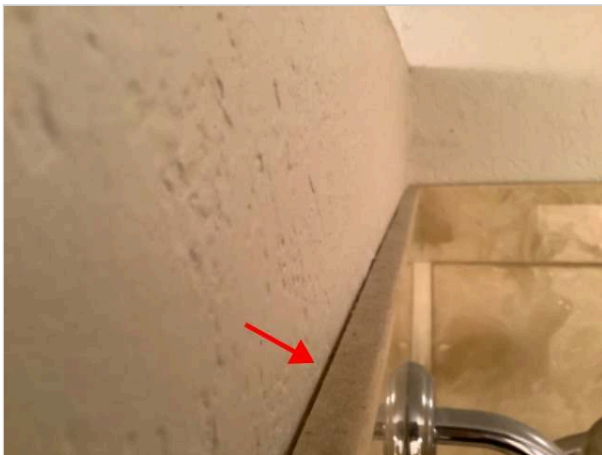
One or more exterior faucets didn't have anti-siphon devices, which is not to today's standards. The top of the right bath shower enclosure was not sealed at the intersection with the wall. The spigot was gapped from the bathtub in the hall bath. The gasket under the right bath shower door did not seal tight and water spritzed out under the door during use.

Not sealed

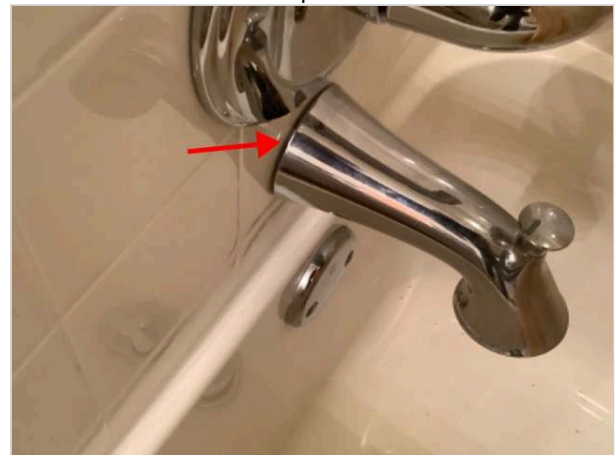
Gap

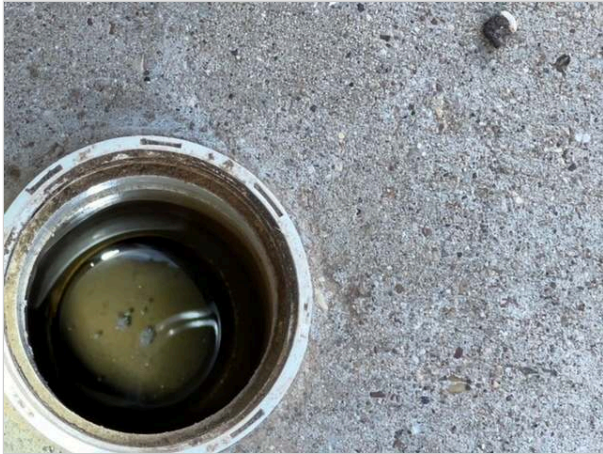
Standing water was noted in the sewer drain at the clean-out between the house and garage and on the side of the garage. Sewer vent pipes were not painted above the roof.

Water in cleanout

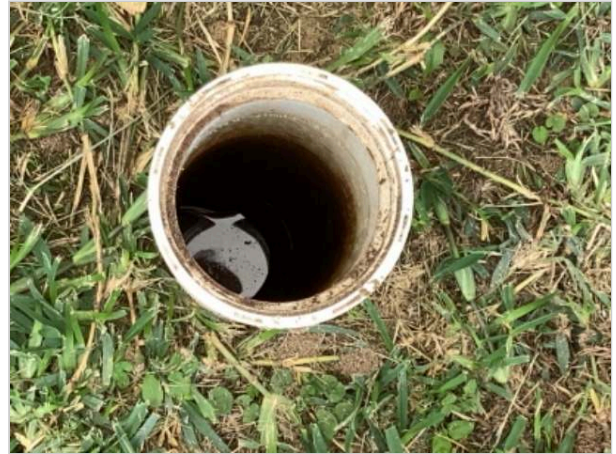
Water in cleanout

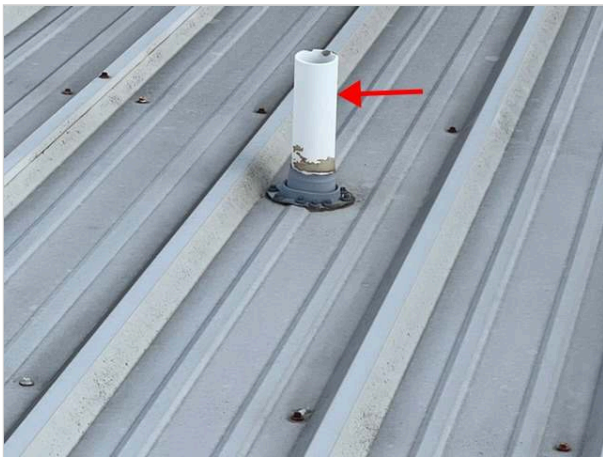
Not painted

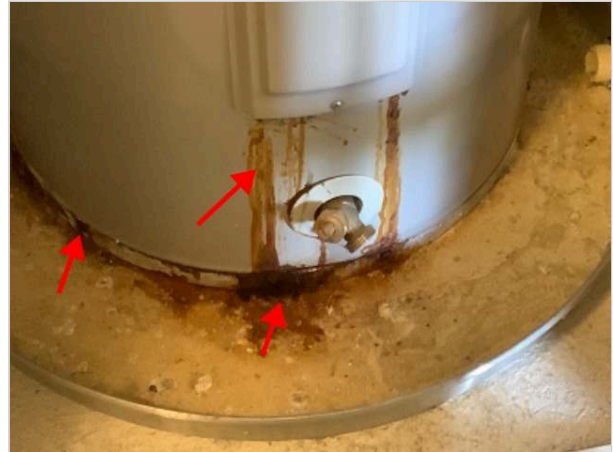
The water heaters did not have expansion tanks which is required per today's standards when a water pressure reducing valve is on the water line. There was corrosion on the lower tank of the water heater located in the hall closet, apparently from a leak at the lower element. There was not a leak observed at the time of the inspection. The garage water heater lower element was not 18" above the garage floor.

Corrosion
