# Inspection Report

7529 FM 2446  
FRANKLIN TX 77856

# PROPERTY INSPECTION REPORT

**By:** Tom Rike TREC 20478 / Tucker Inspections 11/30/2020

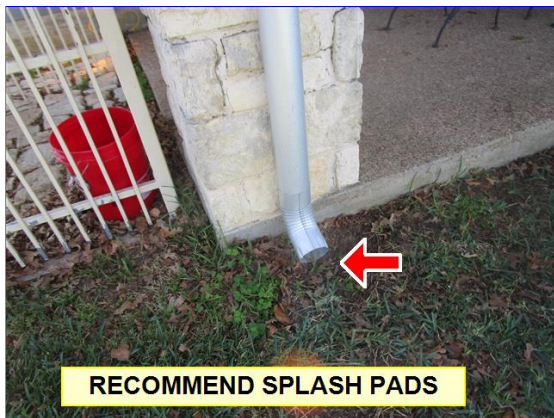
B. Item 1(Picture)

Note: Recommend splash pads below the gutter downspouts to avoid erosion.

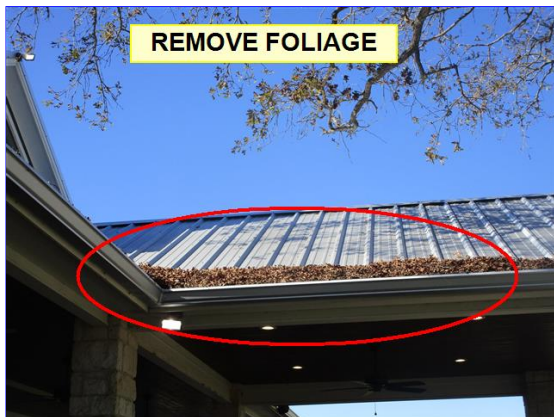
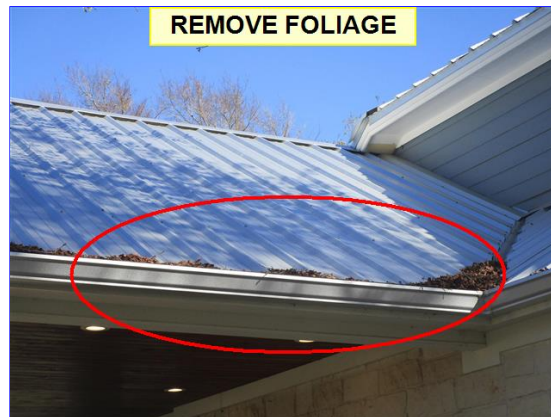
This is a metal roof that was found in good condition at the time of this inspection.

Note: The foliage on the roof needs to be removed to allow proper drainage.

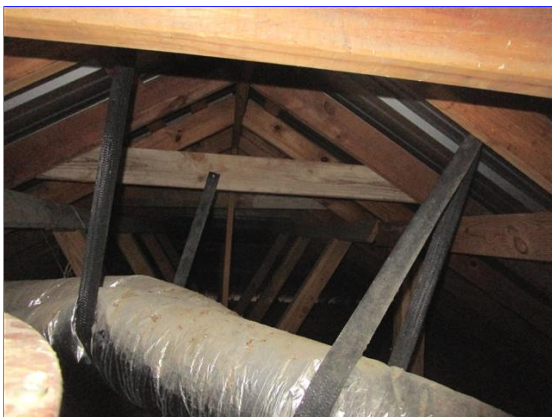
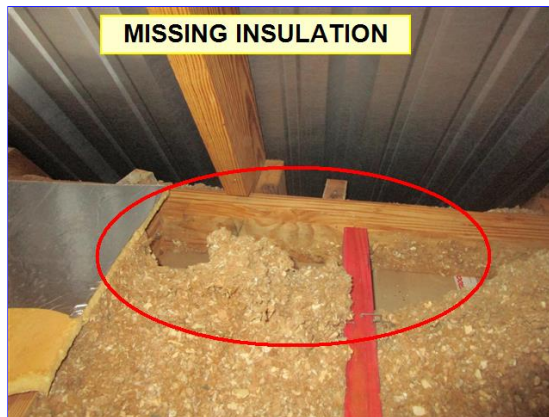
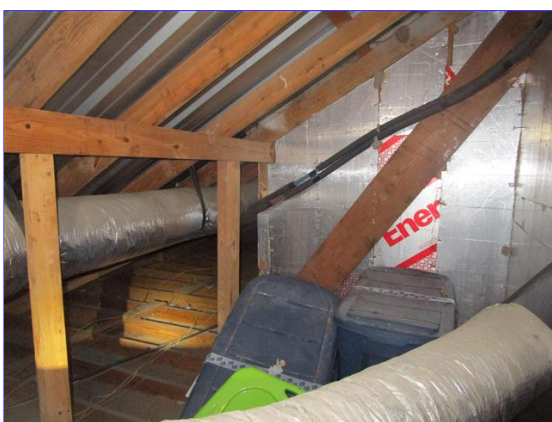
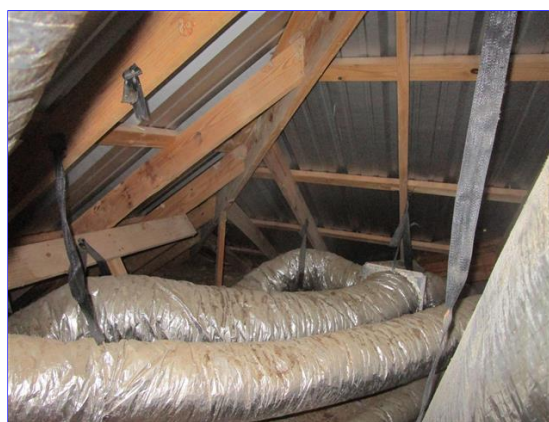
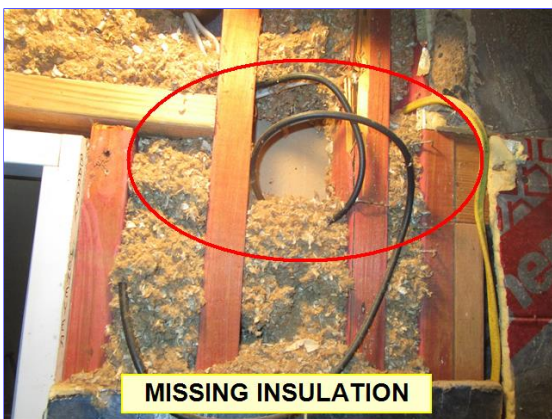
The attic framing in this home is typical for the era of its construction. It lacks enough bracing to meet current building standards. However, the framing still appears to be performing as intended with only signs of minor rafter deflection.

The insulation in the attic does not meet the current building standard of R30 value.

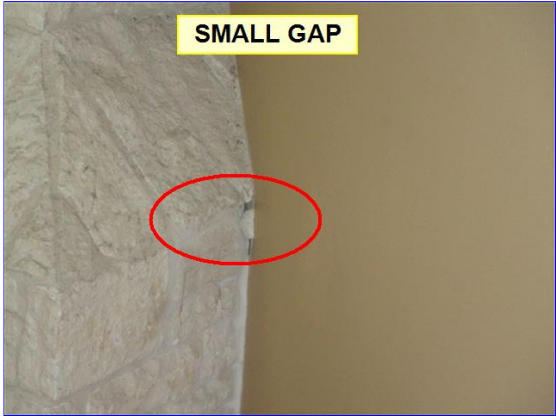
E. Item 1(Picture)

Note: There was a small gap between the living room unit wall/stone.

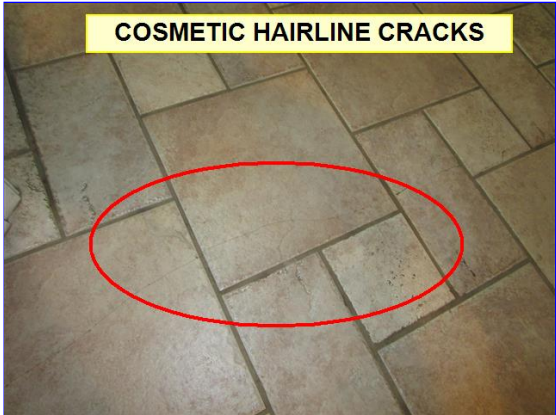
F. Item 1(Picture)

note: There were cosmetic cracks in multiple tiles throughout the unit.

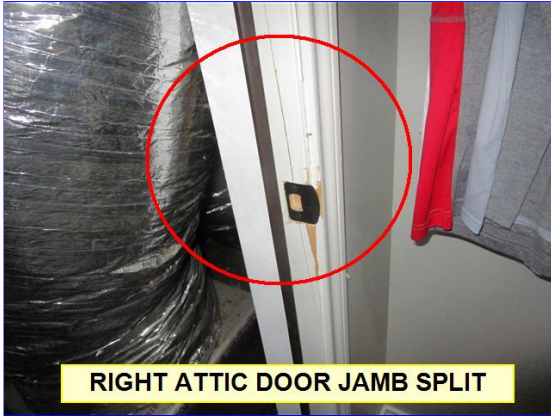
G. Item 1(Picture)

The left attic door was not fire rated doors. The doors were hallow core.

The rear french door knob lock was not operating.

The upstairs left bedroom door rubs the jamb when opening/closing.

The upstairs right attic door jamb was split.

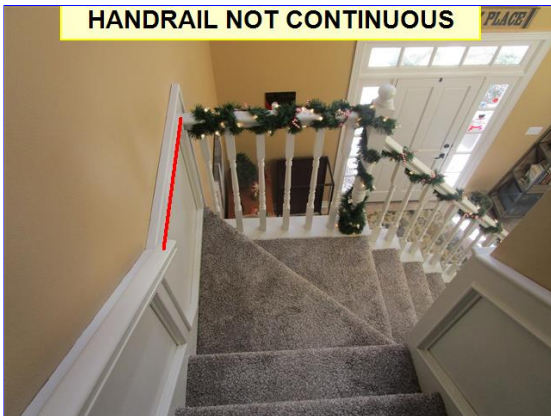
H. Item 1(Picture)

The handrail for the main stairwell steps was not continuous. *This would not meet current building standards.*

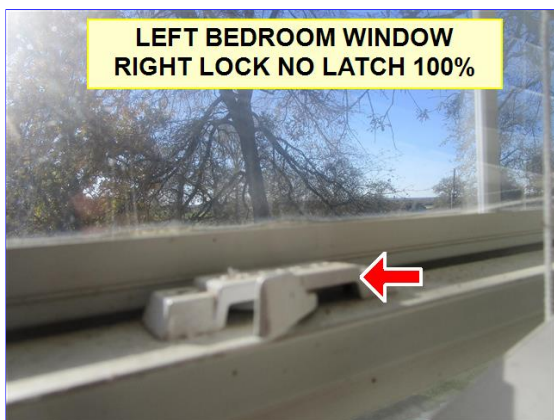
I. Item 1(Picture)

Screens:(3) Torn

Windows with broken seals:(2) Window panes - The entry upper center window.

The upstairs left bedroom window - right lock would not latch 100%.

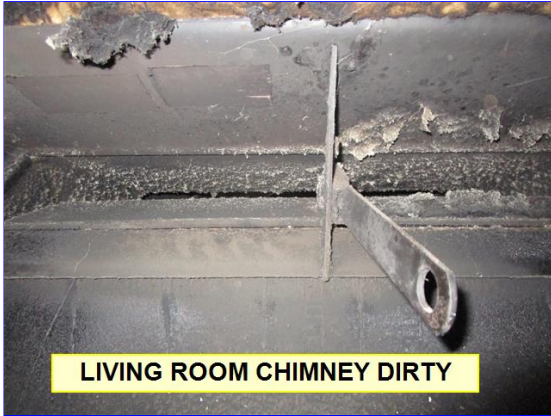
J. Item 1(Picture)

The fireplace and chimney need to be cleaned.

MASTER BEDROM: This is a metal pre-fabricated electric unit that was not operating at the time of this inspection.

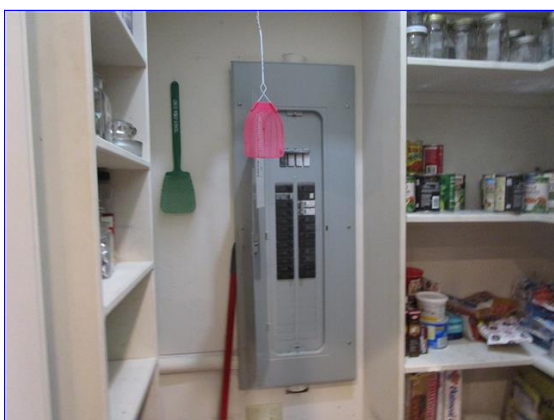
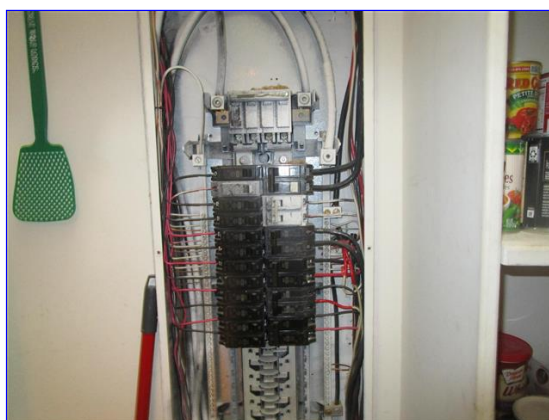
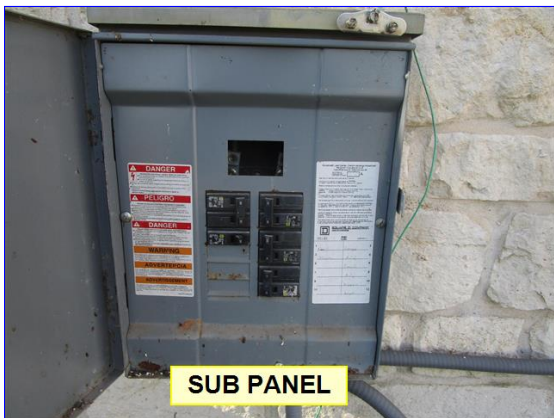
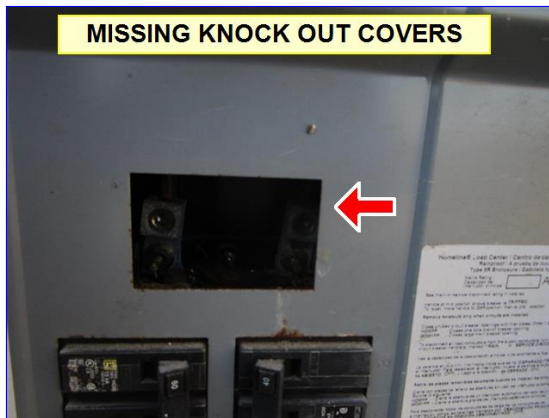
All components were found in satisfactory condition at the time of this inspection. The panel was labeled and located in the pantry. There was a sub panel on the right exterior wall.

The sub panel was missing knock out covers.

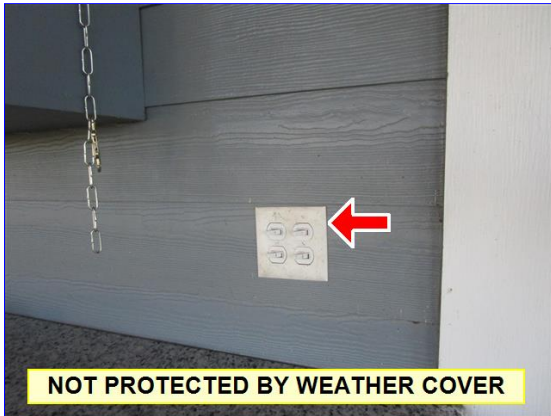
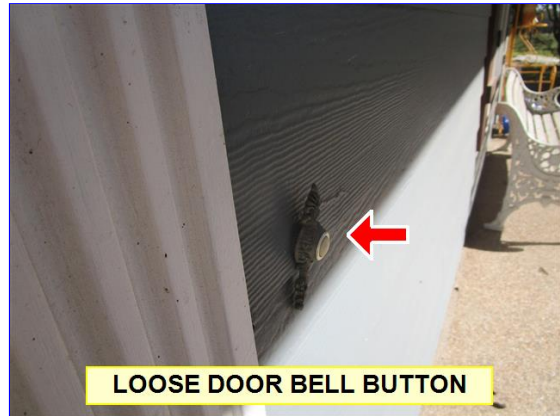
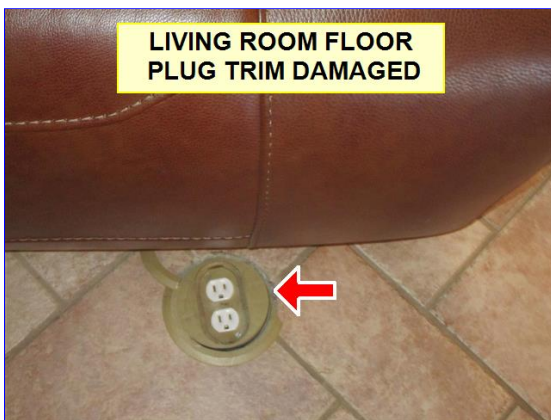
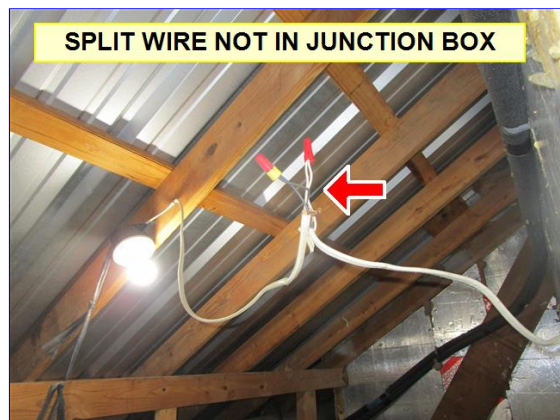
The smoke detector outside the downstairs sleeping areas does not have a battery.

There was not a labeled carbon monoxide detector outside of the downstairs sleeping areas.

The rear porch switches were not protected by weather covers.

The carport outlet was not ground fault protected.

The right rear flood light was not operating.

The left rear flood light was not operating.

The doorbell button was loose from the wall.

There were no fire protective covers over the closet light bulbs. *This would not meet current building standards.*

The recessed light above the upstairs right bedroom-bathroom shower was not operating.

The upstairs left bedroom fan was not balanced. This means the fan wobbles when operating.

The utility room outlets were not ground fault protected.

Not all of the bedrooms had a smoke detector present. *Recommend installing detectors for safety.*

The master bedroom fan light was not operating.

The master bathroom tub motor GFCI outlet would not trip when tested and needs to be replaced.

The master bathroom GFCI outlet would not trip when tested and needs to be replaced.

The kitchen GFCI outlet would not trip when tested and needs to be replaced.

Not all of the kitchen outlets were ground fault protected. *This would not meet current building standards.*

The living room floor plug trim was damaged.

There were split wires in the attic not protected in a junction box.

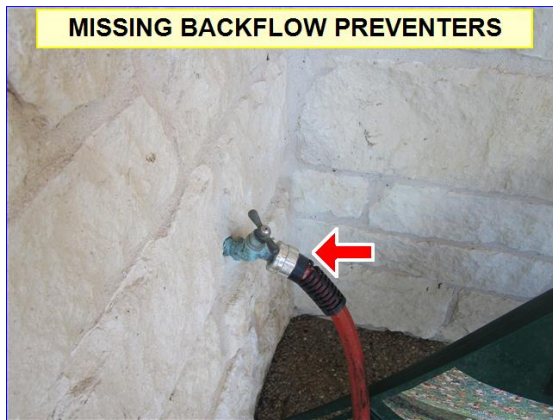
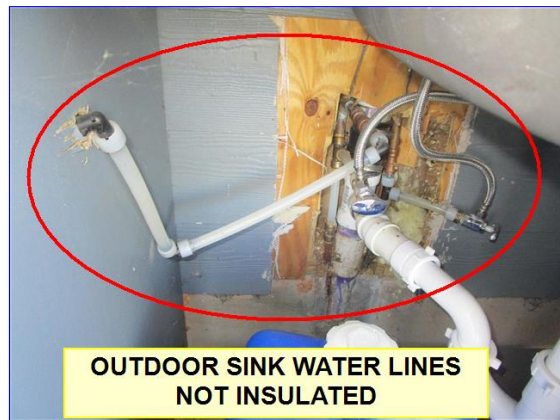
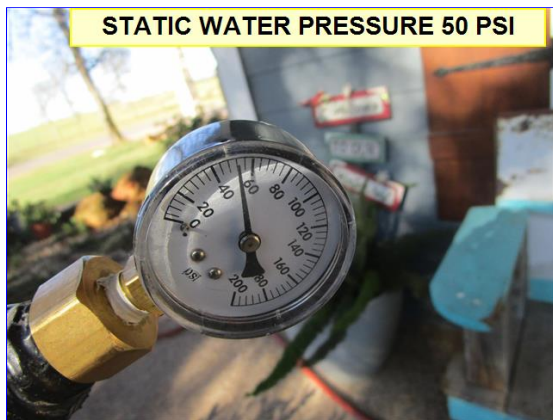
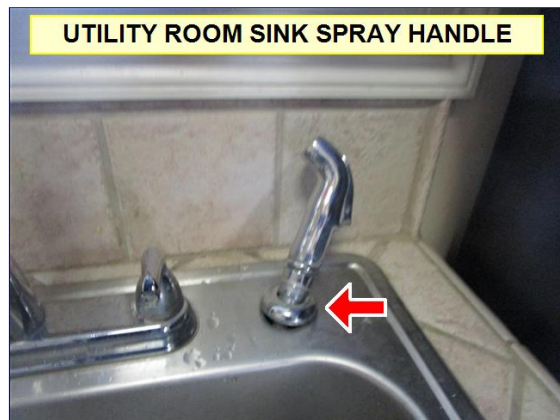
There were missing back flow preventer on the exterior hose bibs.

The outdoor sink water lines were not insulated.

The utility room sink spray handle holder was detached from sink.

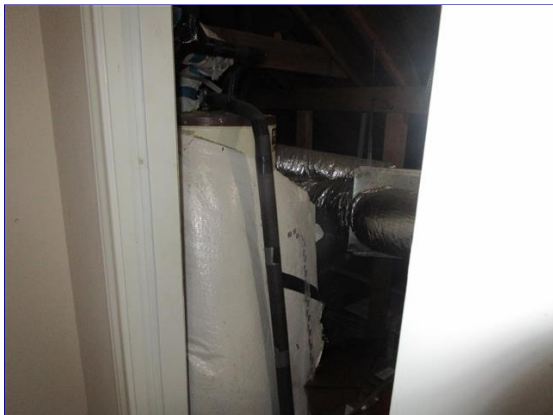
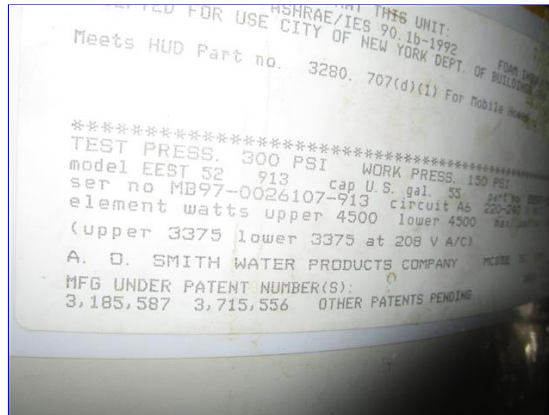
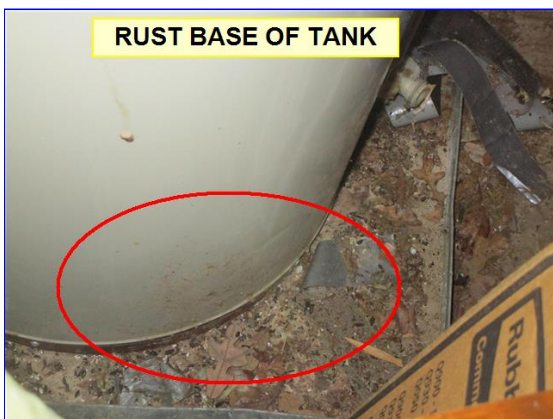
There was rust along the base of the tank. The unit appears to be a 1997 model. Most professional plumbers give a water heater a 10-15 year life span. Recommend replacement.

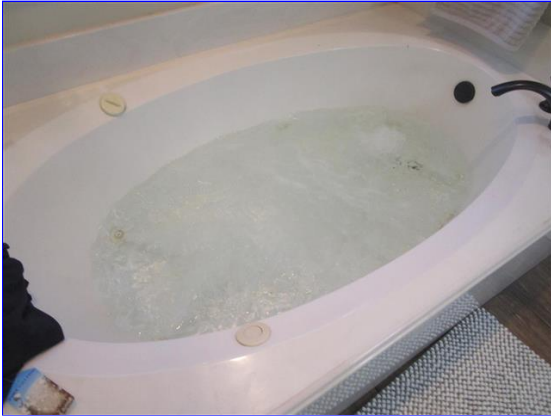
D. Item 1(Picture)

The motor was plugged into a ground fault protected outlet. The GFCI outlet would not trip when tested and needs to be replaced.

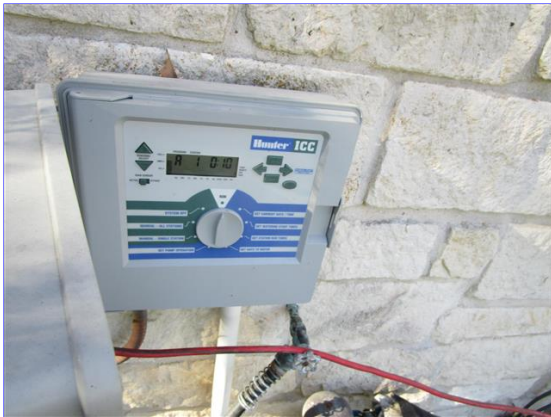
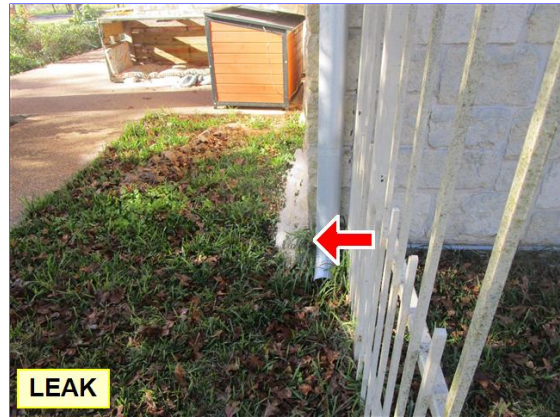
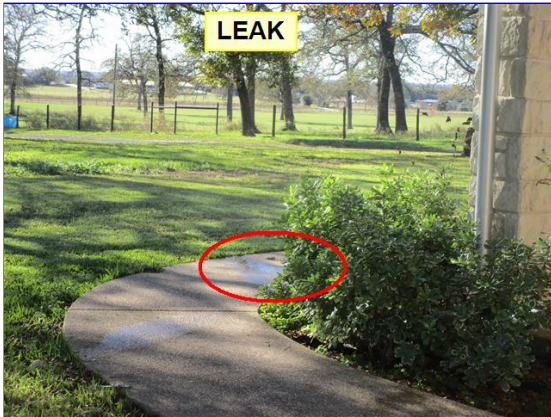
Not all of the zones were operating at the time of this inspection. There were multiple leaks present. Recommend complete further review of the system by a professional irrigation company.

There was not a rain delay sensor present. *This would not meet current building standards.*
