Texas WDI Report For: 7529 FM 2446, Franklin, TX 77856 Prepared Exclusively For: Chance Rosewell Inspected On: Monday, November 30, 2020

TEXAS OFFICIAL WOOD DESTROYING INSECT REPORT

7529 FM 2446	Franklin	77856		
Inspected Address	City	Zip Code

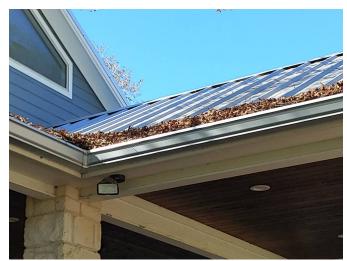
K. Debris on roof & gutters

Remedies: Keep all debris away from the home. Bricks, Stored wood, leaves & Compost, Keep Gutters & Roof clean of leaves & limbs.
