Form Information

Form Name	System Inspection
Submitted by	Mark
Date/Time	01/10/25 01:37 PM MST
Address

Address:	177 Gray St
Property Picture

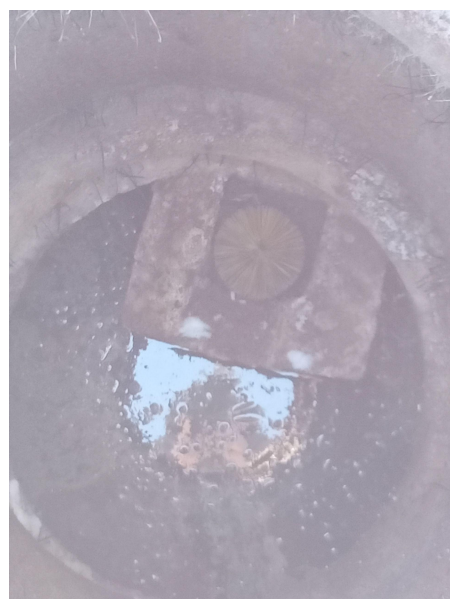
Additional Components

Notes: Brush filter- the filter was unable to be removed at this time.

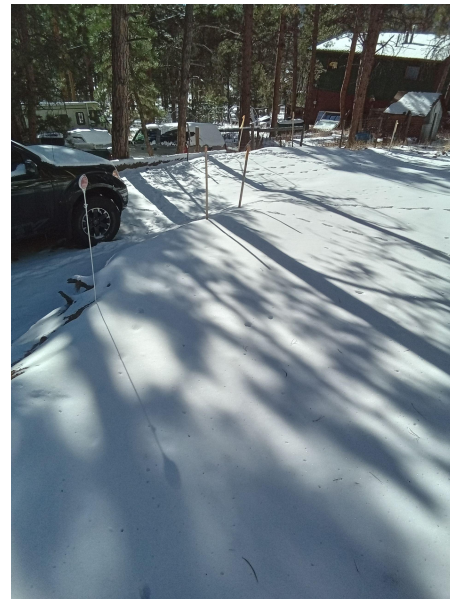
Leach Area

Leaching Area	At the time of the evaluation – the leaching area appears to be functioning for its age
Secondary leaching area	NA
Observation port(s)	No
If Yes, how much fluid in port by inches?	NA
Effluent Surfacing	No
Surface Condition of the Leaching Area	snow cover
What is the Distance and Direction of the tank(s) to Leaching Area or Discharge Location?	35ft Southwest
Is the Leaching Area Under Compaction or a Structure?	Yes
Additional Leaching Area or Discharge Location Notes	The leaching area appears to be located under the driveway.
Inlet Line Evaluation	The inlet line appeared to be open from the tank to the building, There was no visible cracks or disconnections, The inlet line is entering the tank at a negative fall, There was a small low spot between the tank the building – See notes below, There was a small amount of buildup in the line
Outlet Line Evaluation	See notes below
Drain Line Additional Notes	At this time we were unable to scope the outlet line due to lack of access and not being able to pull the brush filter however the tank is at the proper operating level therefore indicating the line is open from the tank to the leaching area.

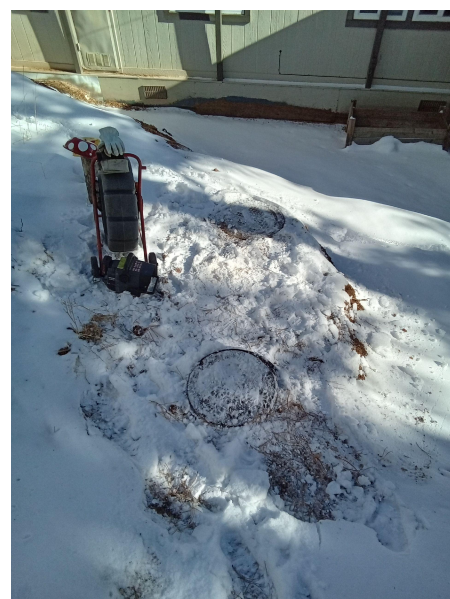
Is the System Acceptable for continued use?	Yes, The system passes the County's minimum requirements for continued use
Tank w/ Lids Back On
