60 Liberty Ln  
Highland, IL 62249

Prepared For: Amy Cadagin

Inspected On Thu, Feb 6, 2025 at 1:00 PM

Metro East Home Inspection LLC

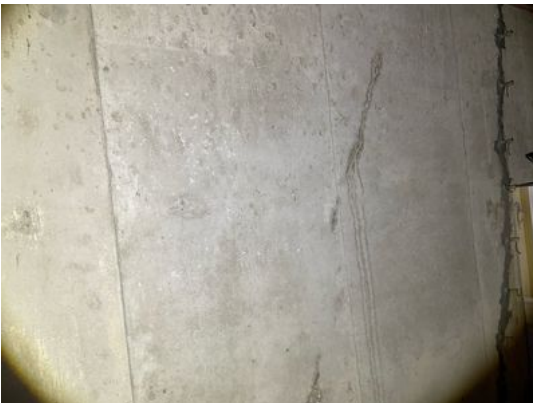
Minor settlement cracks were observed in the foundation walls. This implies that some structural movement of the building has occurred. Cracks of this type should be watched for any sign of additional movement. In the absence of any sign of ongoing movement, repair should not be necessary.

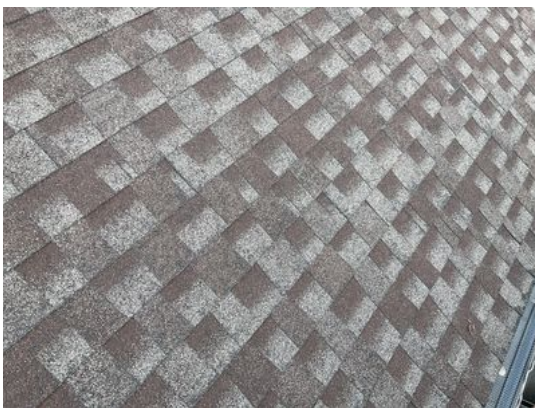
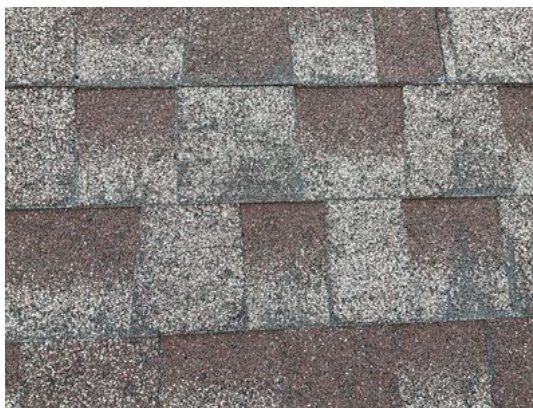
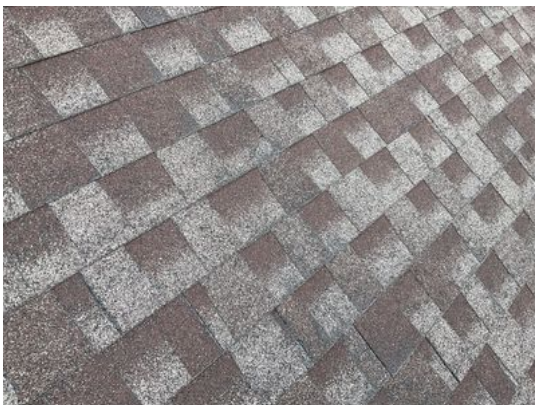
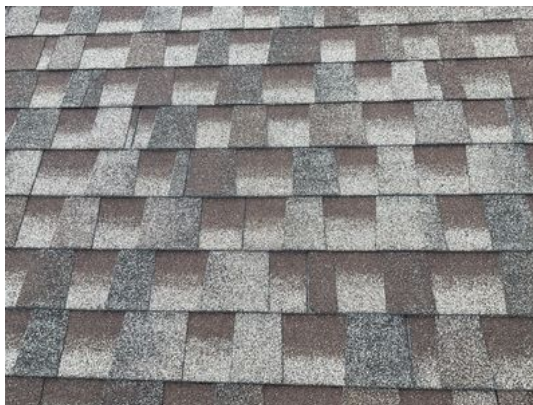
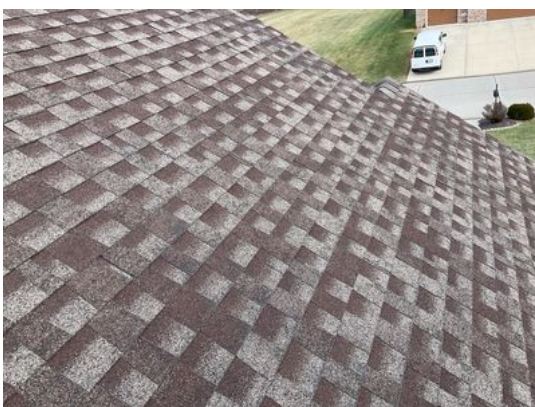
The roofing is in less than ideal condition. Excessive granular loss, wear and tear as well as exposed shingle fibers were noted consistently across the roof covering. Damaged or missing roofing material should be repaired. All roof penetrations should be examined and sealed as necessary. Refer to a licensed roofer for further review and recommendations.

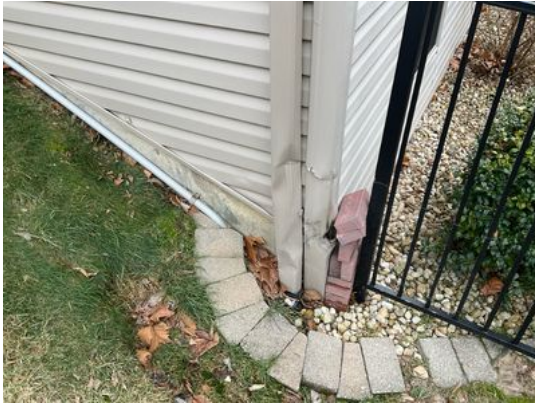
**Comment 4**

Loose or damaged downspouts should be repaired promptly.

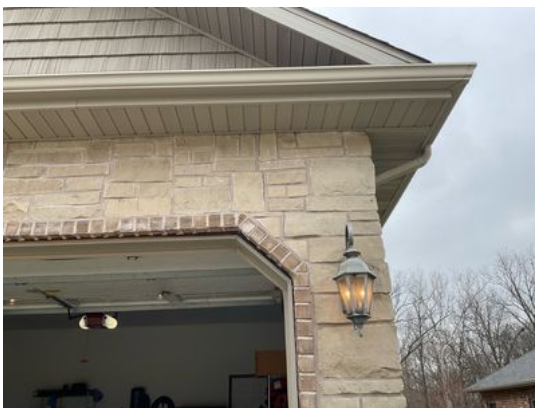
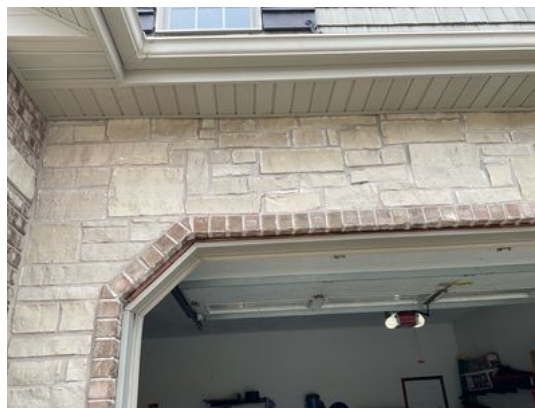
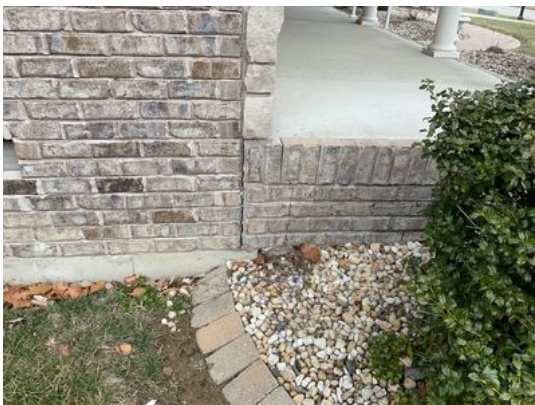
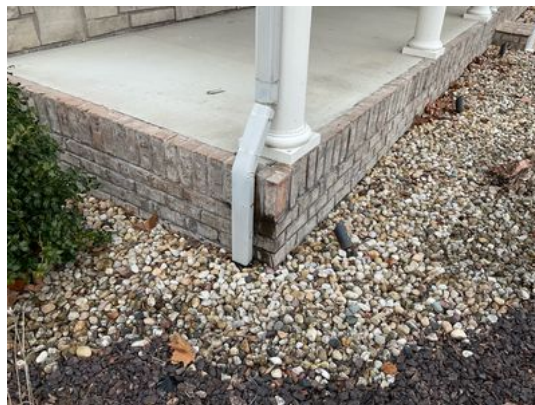
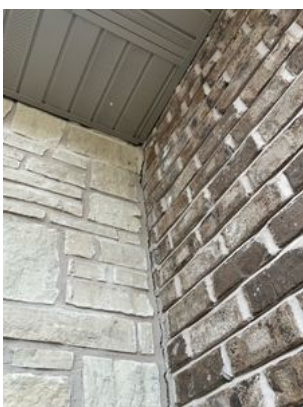
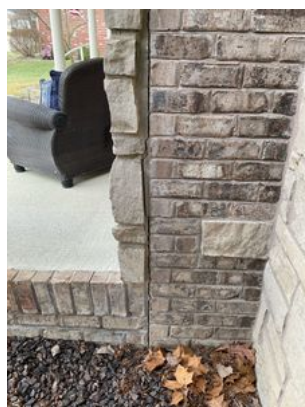
Common cracks were observed on the exterior walls of the house. This implies that structural movement has occurred. The location, size and shapes of these cracks is common. The inspection did not find evidence of significant movement requiring immediate major repairs.

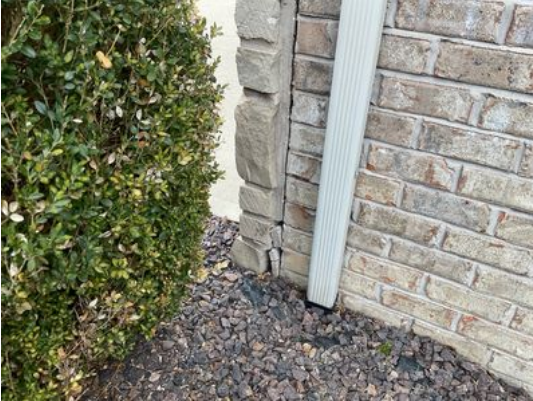
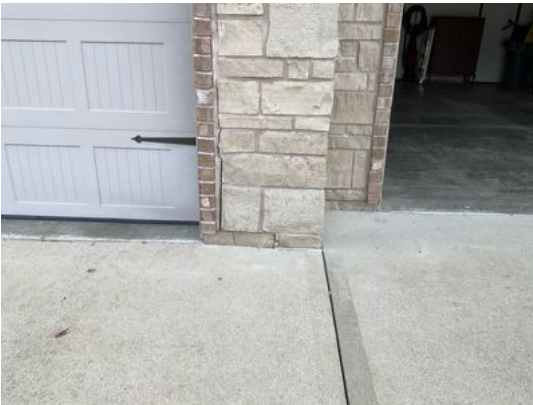
**Comment 6**

Localized tuck-pointing of the deteriorated mortar at the front exterior wall is recommended.

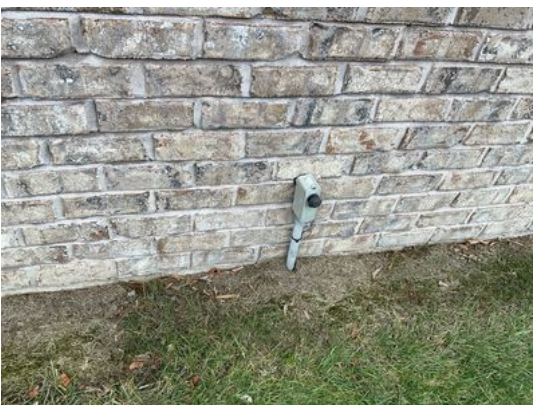
**Comment 7**

All exterior wall penetrations should be sealed to prevent moisture penetration.

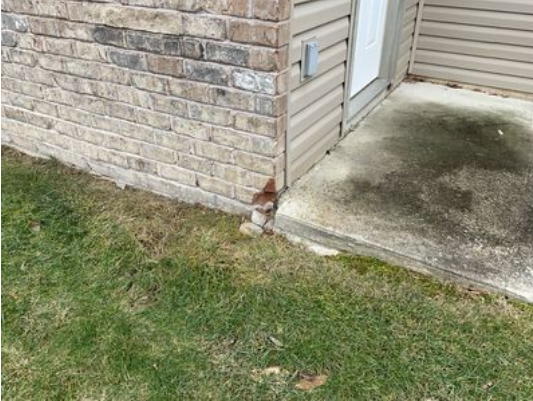
**Comment 8**

Damaged brickwork should be repaired to preserve the wall.

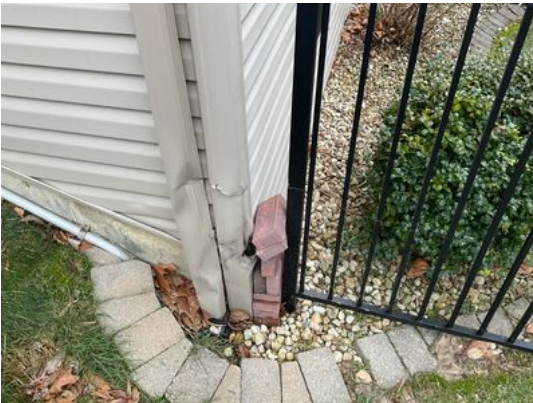
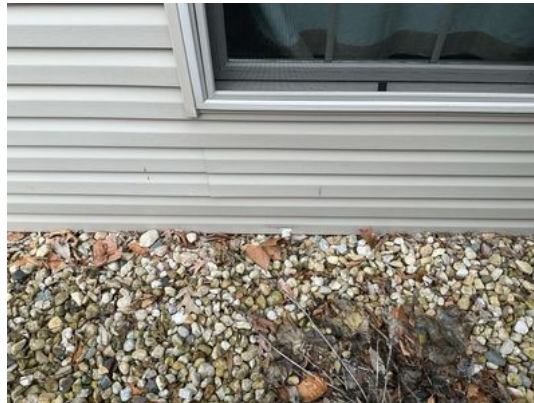
**Comment 9**

It is recommended that the damaged siding around the house be repaired or replaced as needed.

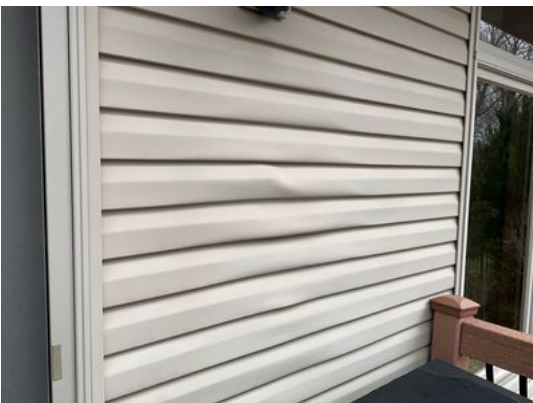
**Comment 10**

Warped siding at the rear deck should be replaced as needed.

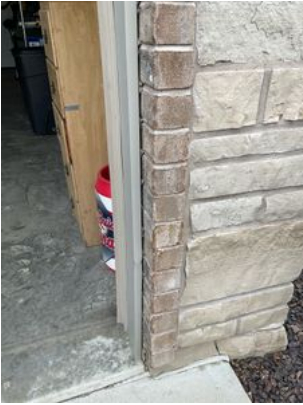
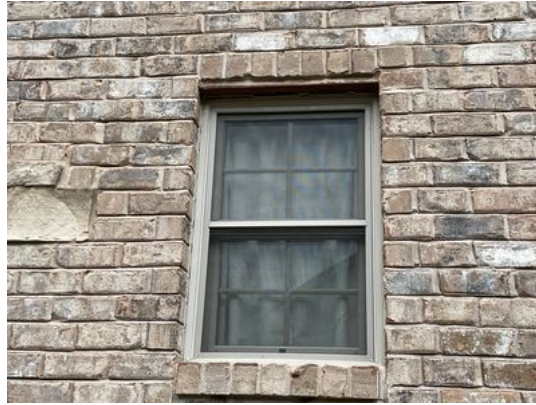
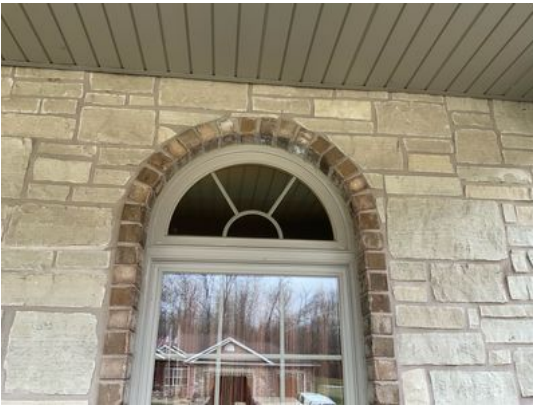
**Comment 11**

Window and door frames require caulking repairs at the exterior of the home.

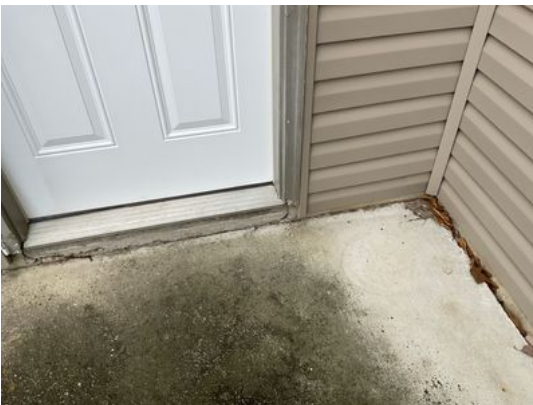
**Comment 12**

Localized rot was observed in the garage service door frame. Following repair of the damaged areas (which should be combined with exterior painting/maintenance) proper maintenance and control of water from roof or surface runoff can avoid further damage.

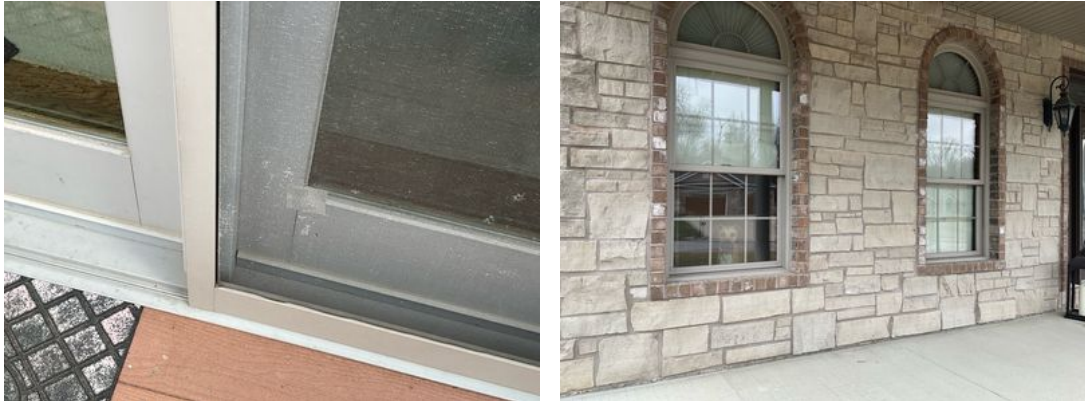
**Comment 13**

Any damaged or missing window and door screens should be repaired or replaced as desired.

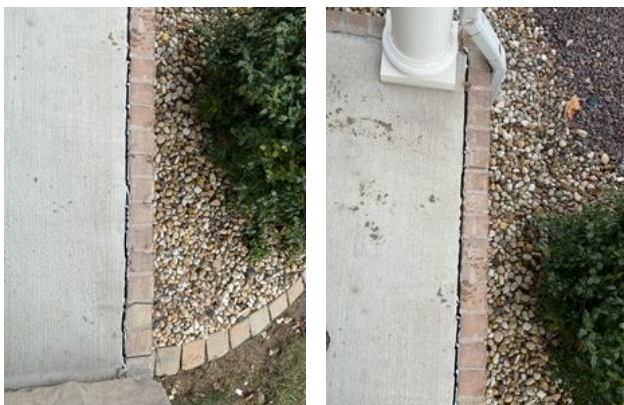
**Comment 14**

The brick veneer wall at the left side of the front porch appears to be pulling away from the porch. Should further movement occur larger than typical repairs will be needed. Refer to qualified contractor for further review and recommendations.

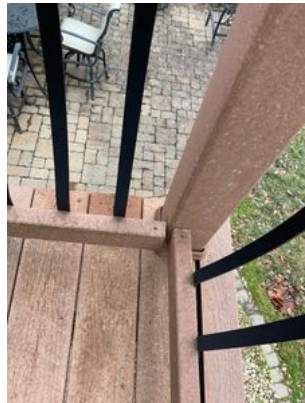
Loose railings at the rear deck should be better secured.

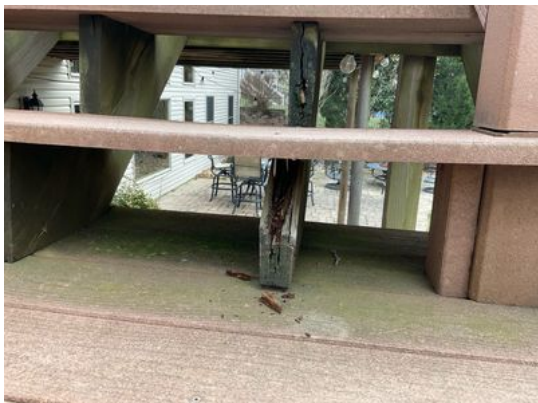
**Comment 17**

The deck shows evidence of rot. Replacement may eventually be desired. In the interim, localized repairs should be undertaken.

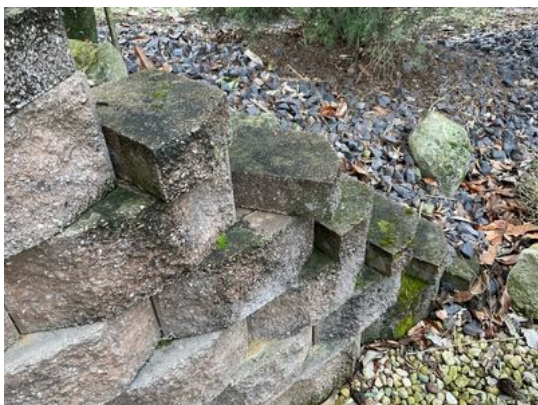
**Comment 18**

Loose blocks at the block retaining walls should be better secured.

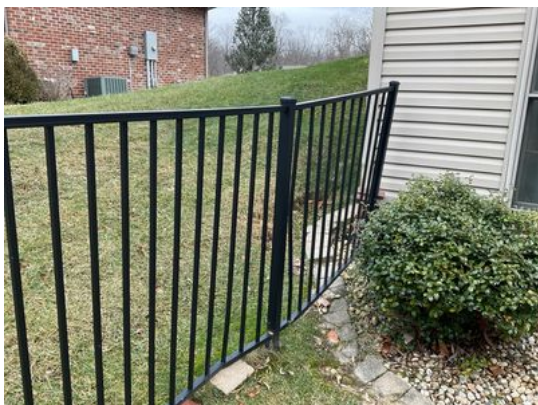
**Comment 19**

The fencing is in only fair condition. Minor repairs such as gate adjustments, board/post replacement or post alignments are needed.

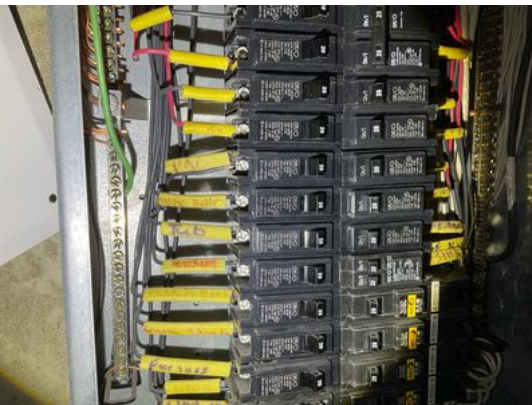
Circuits within the main distribution panel that are doubled up (referred to as "double taps") should be separated. Each circuit should be served by a separate fuse or breaker.

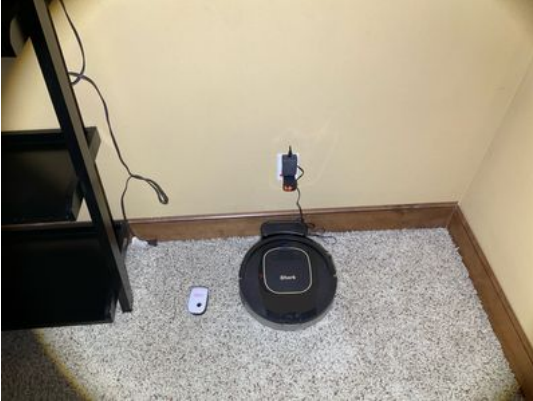
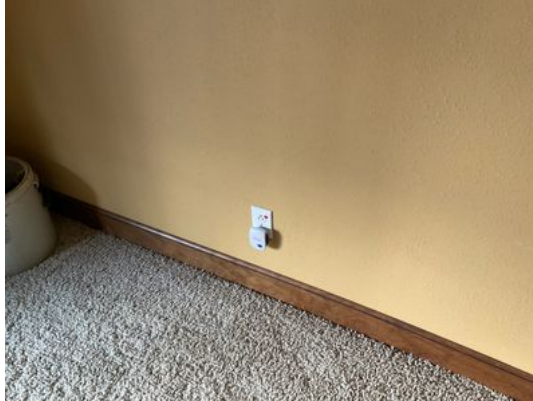
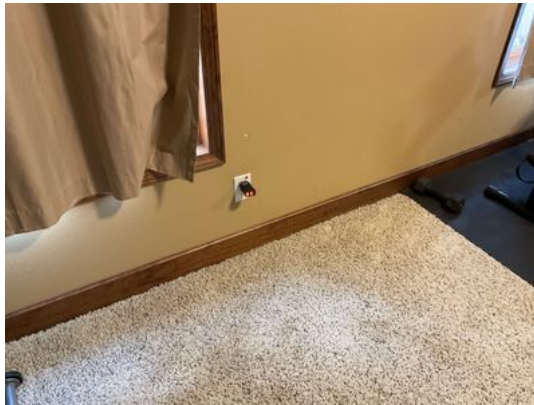
**Comment 21**

Loose outlets in the basement family room and bedrooms should be better secured.

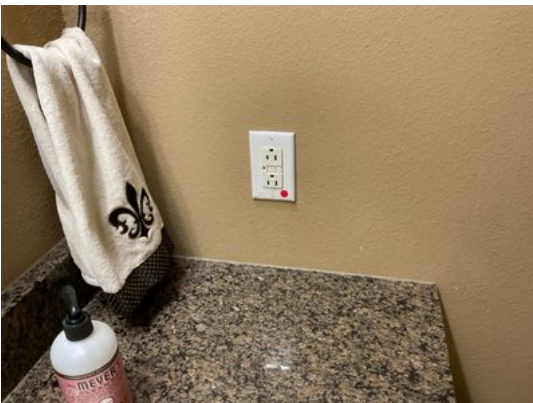
**Comment 22**

The damaged outlet cover plate in the hallway bathroom should be replaced to avoid a shock hazard.

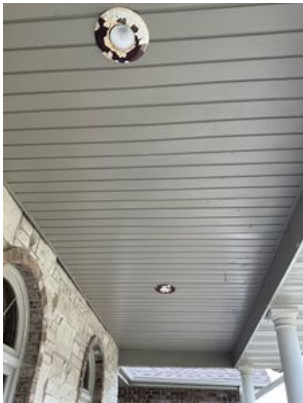
**Comment 23**

The metal can lights at the front porch are rusting. They should be painted with an appropriate paint or replaced.

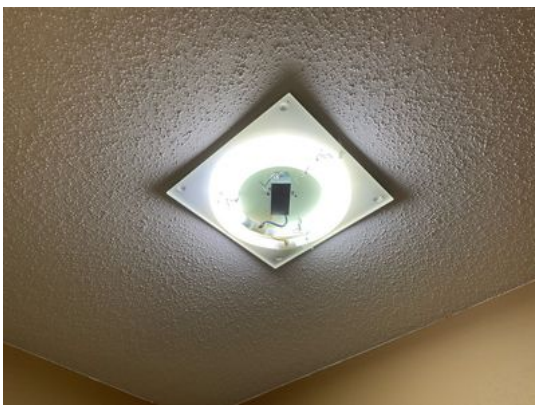
**Comment 24**

The missing light fixture cover in the laundry room should be replaced.

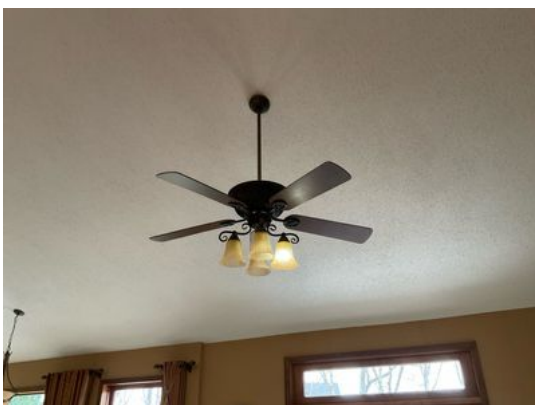
**Comment 25**

The ceiling fan fixture at the dining area is inoperative should be repaired or replaced as desired.

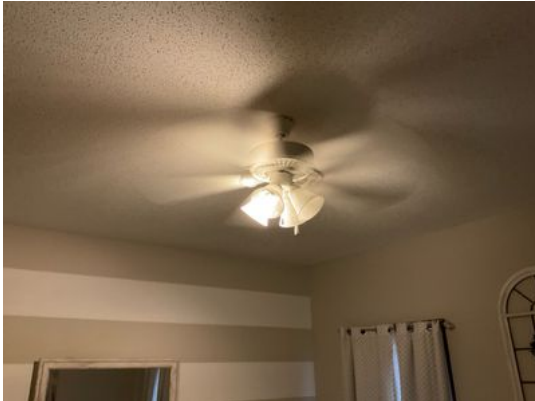
**Comment 26**

The ceiling fan in the rear left bedroom wobbles when operated and may require balancing.

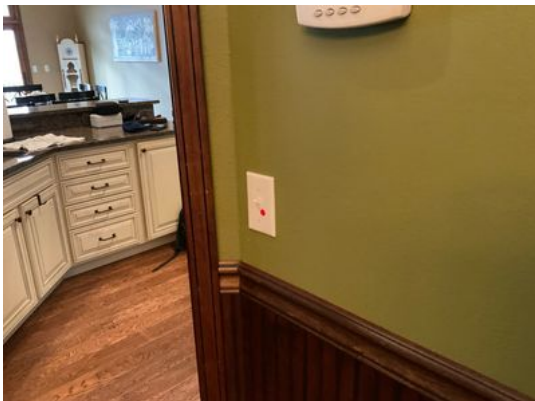
**Comment 27**

The three-way light switch serving the formal dining room appears to be wired improperly. This should be investigated further and repaired as needed.

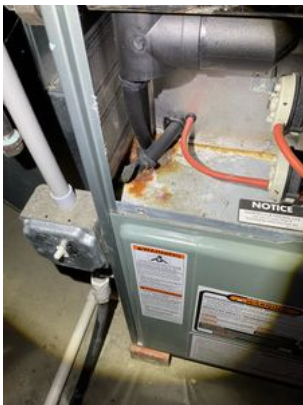
Rusting and evidence of prior leakage was noted at the furnace. These areas were dry at the time of inspection.

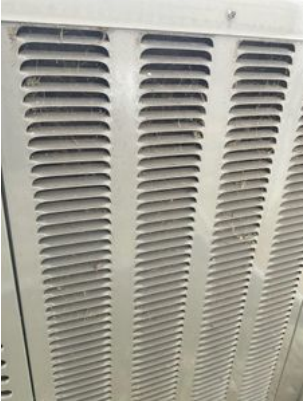
The outdoor unit of the air conditioning system requires cleaning.

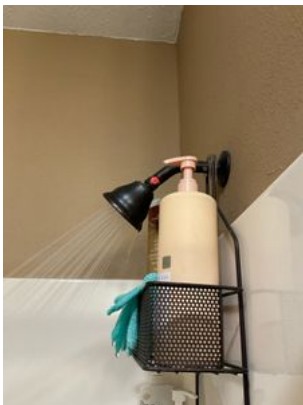
The shower head serving the primary bathroom leaks from the stem connection when operated.

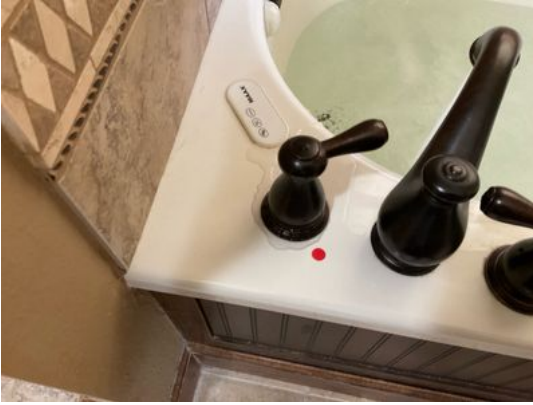
**Comment 34**

The cold/hot water handle serving the master bathroom whirlpool bathtub leaks when operated. Leaky handles are typically caused from faulty and/or damaged "O" rings within the handles.

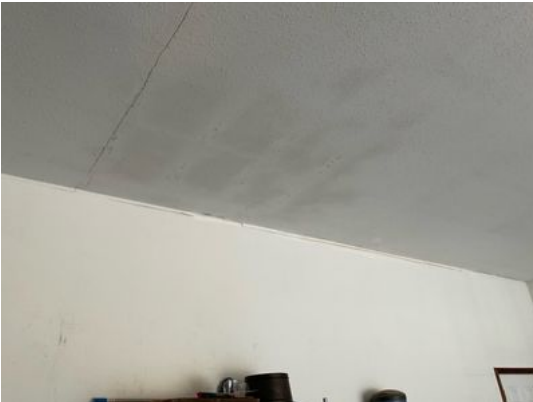
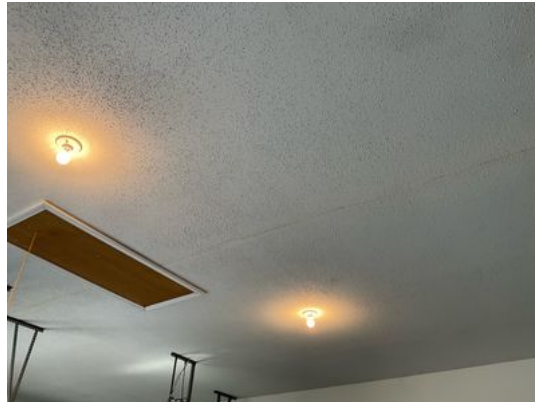
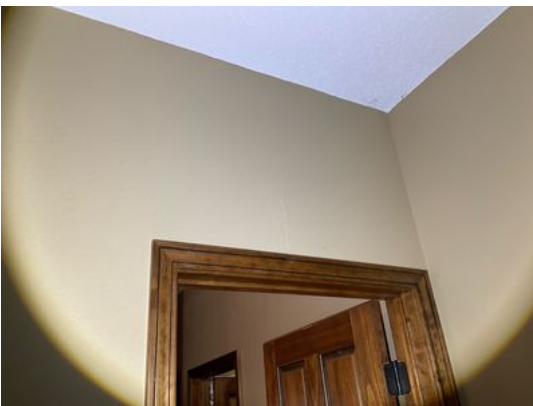
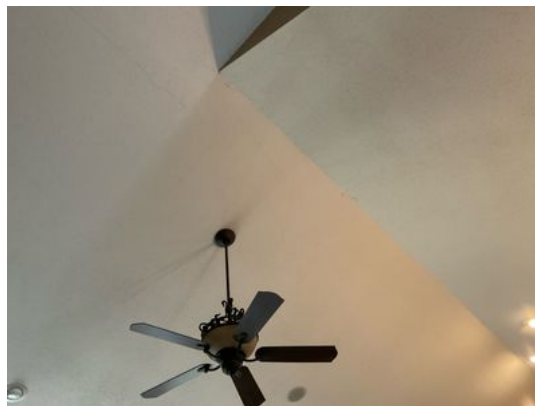
Typical dry wall flaws were observed at various locations throughout the home.

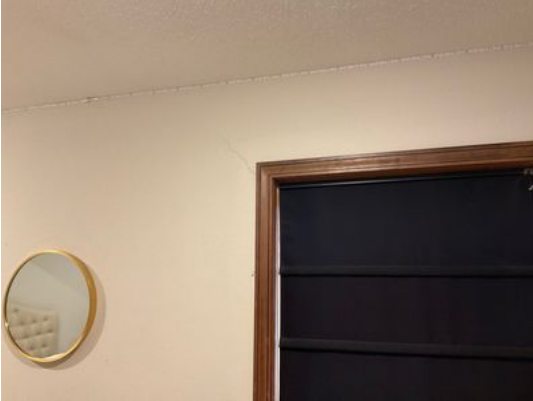
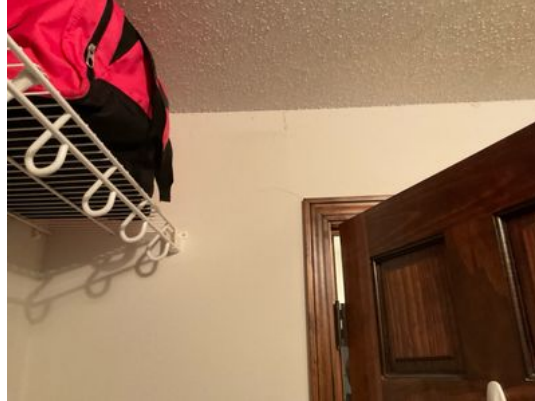
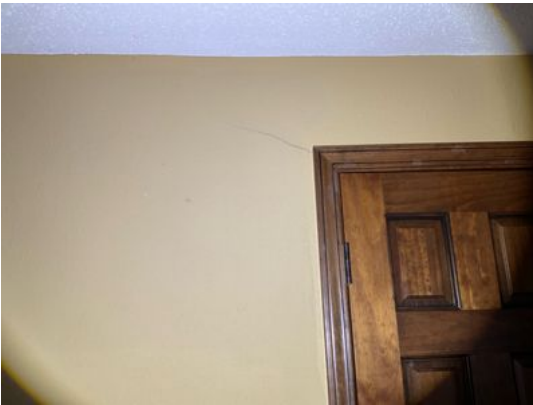
**Comment 36**

Minor cracks in the drywall and/or plaster were noted in the rear left basement bedroom and basement family room.

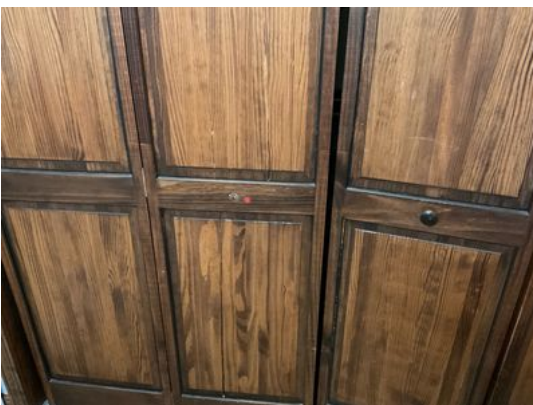
**Comment 37**

Damaged, missing, loose or non-functional door hardware serving the front left bedroom closet should be repaired or replaced.

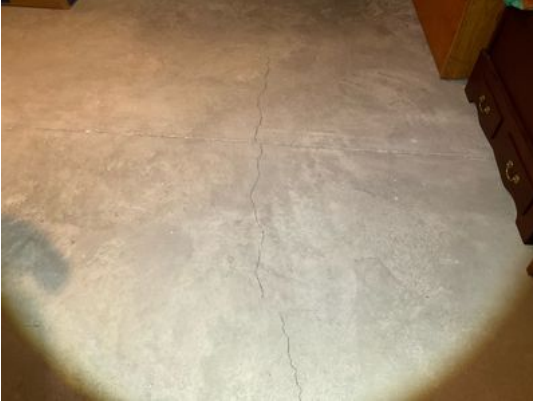
Typical hairline to 1/8" cracks in basement floor. These are not structural issues. Monitor and fill if desired.

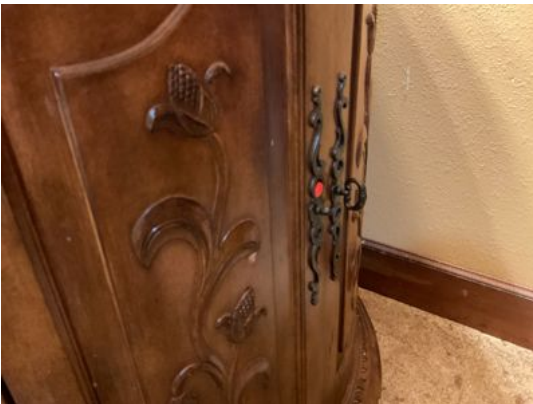
Any damaged cabinet hardware/hinges in the basement bathroom should be repaired or replaced as needed.

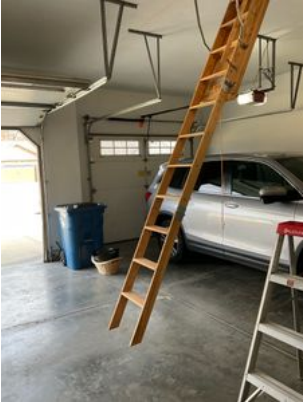
The attic pulldown ladder lax adequate support. The ladder should be extended to reach the garage floor. The ladder is currently unsafe to use in this condition.
