**Property Inspection Report for:
Mary & Jonathan Kroll**

**345 Laguna Rd
Bandera, TX 78003**

PROPERTY INSPECTION REPORT

By: Michael Morissette, Lic #21770 06/25/2021
(Name and License Number of Inspector) (Date)

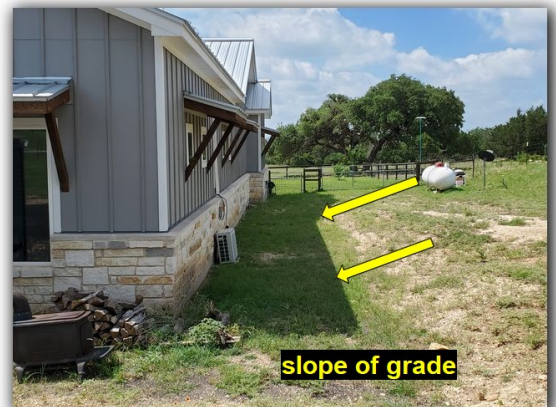
*Grade slopes toward the foundation along the right side. Water may pool at the foundation.
Recommend installation of gutters along the right side to drain water away from the foundation

*Water appears to be pooling at the right side of the front porch. Recommend re-grade of the soil in that area or installation of gutters to drain water away from the foundation

Recommend consultation with Landscape or General Contractor to address/repair deficiencies

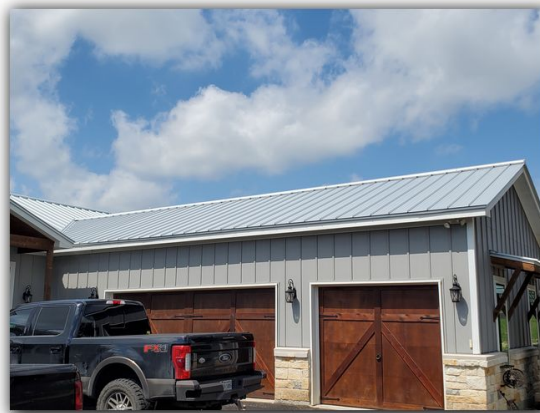
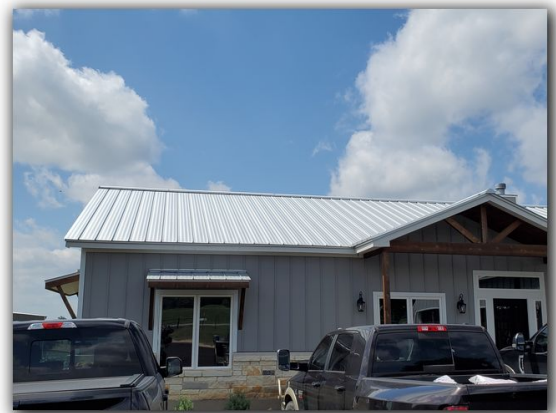
Note: The following pictures show the general condition of the roof covering at the time of inspection

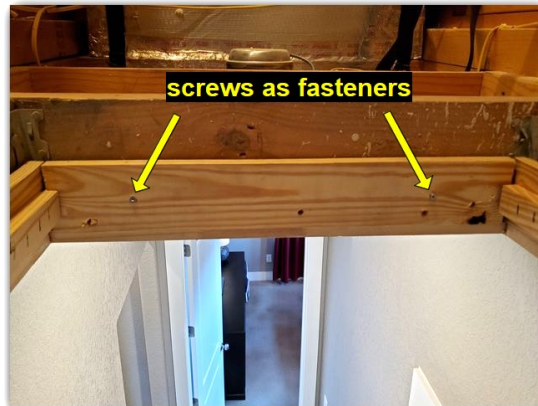
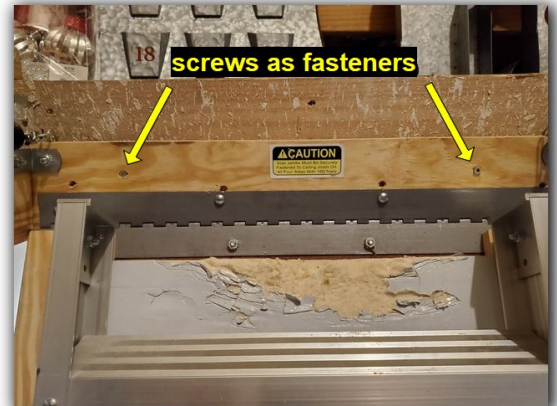
Note: Spray foam insulation was installed. Cannot view roof decking, trusses or framing at roof decking

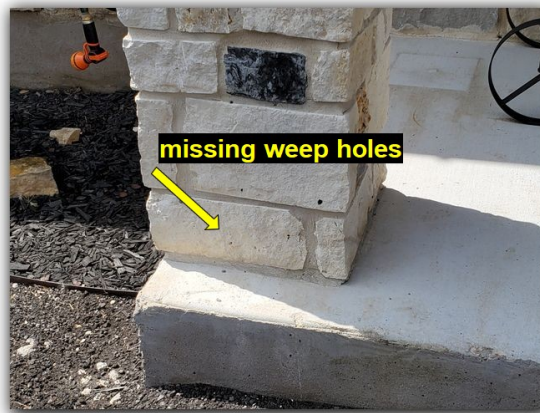
*Weep holes missing at front porch columns

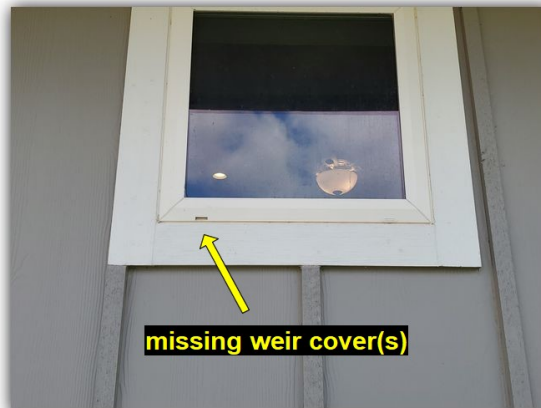
*Weep hole covers (weirs) are missing at exterior window frame(s) at master bedroom windows Recommend replacement to prevent intrusion of insects into window frame

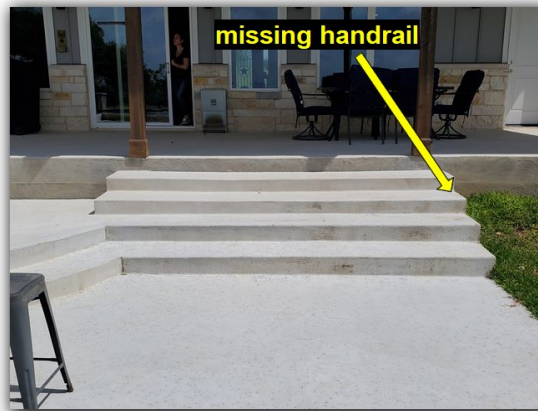
*Stairways at rear porch do not have handrails installed. This condition is a safety hazard

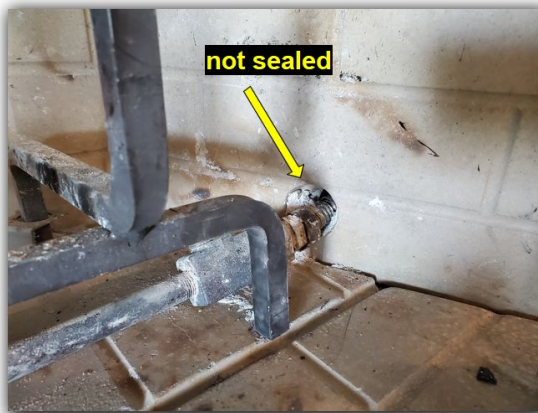
- *Damper does not operate properly
- *Hairline crack in rear refractory plate in firebox
- *Gas pipe penetration in firebox is not sealed. Recommend sealing with mortar/cement or fire-rated epoxy

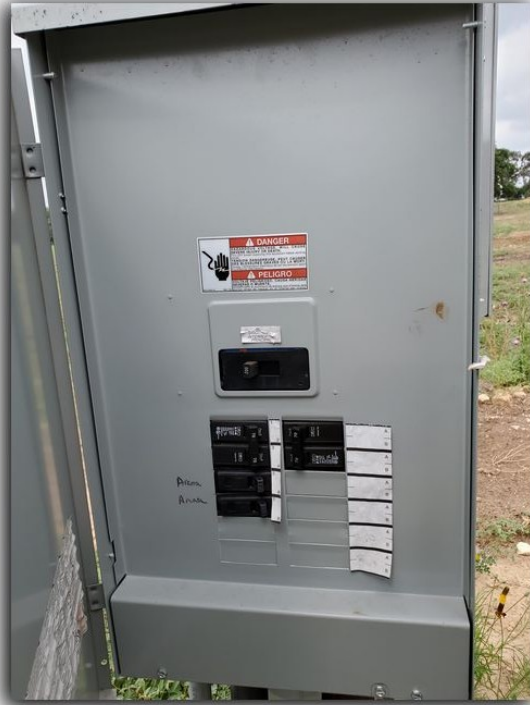
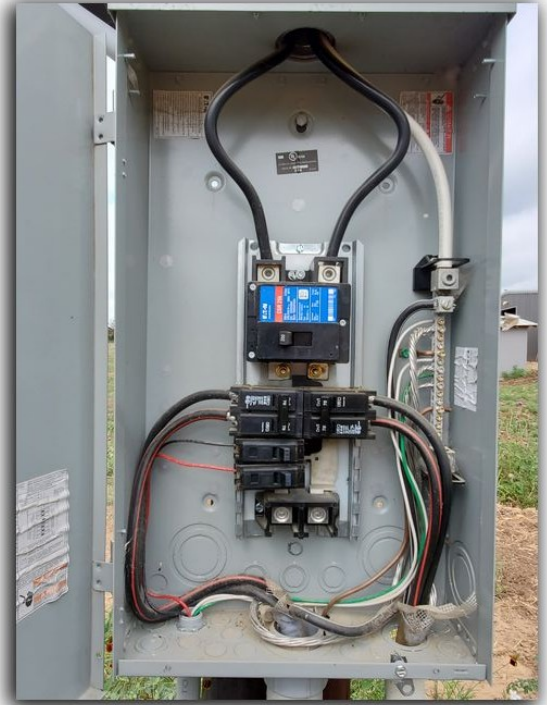
Note: (2) meters are installed/present. Homeowner disclosed that (1) meter is an Agricultural-exemption meter

- *Bushings or strain relief missing where wires pass thru enclosure
- *Lack of anti-oxidant grease on aluminum conductor terminals
- *Knockouts missing in panel enclosure
- *Well pump wiring is not installed in conduit

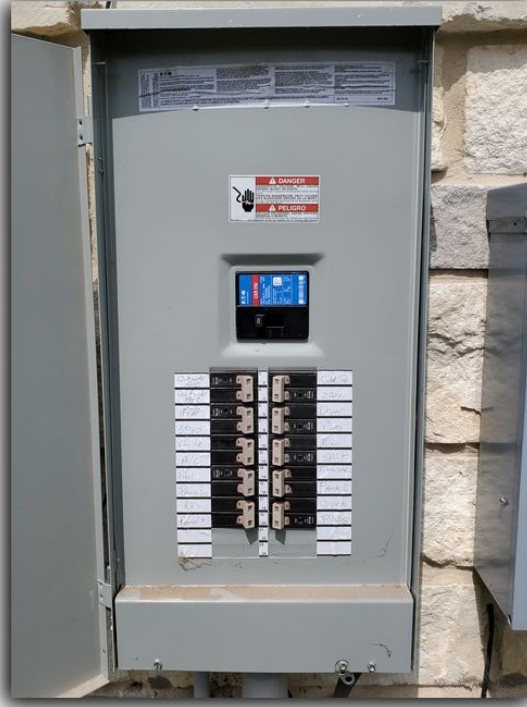
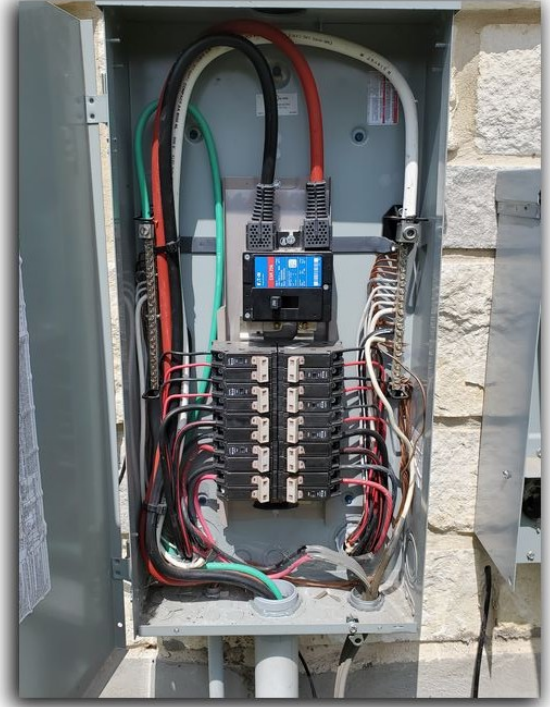
Picture of Main Panel:

Note: Presence of Ground rod below soil level could not be verified

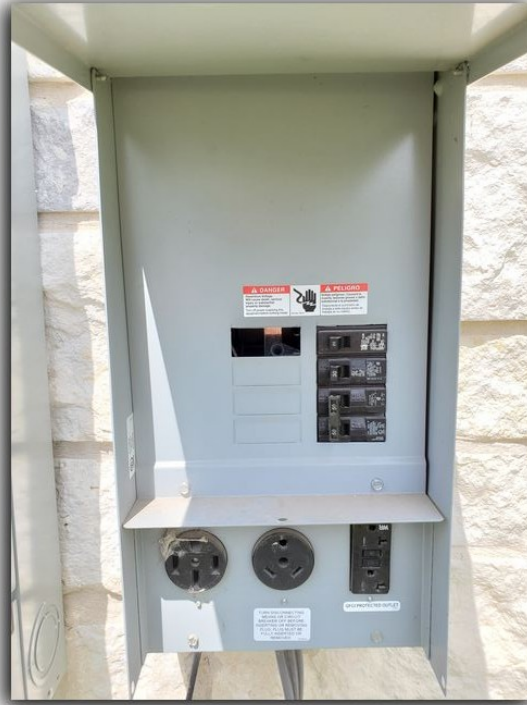
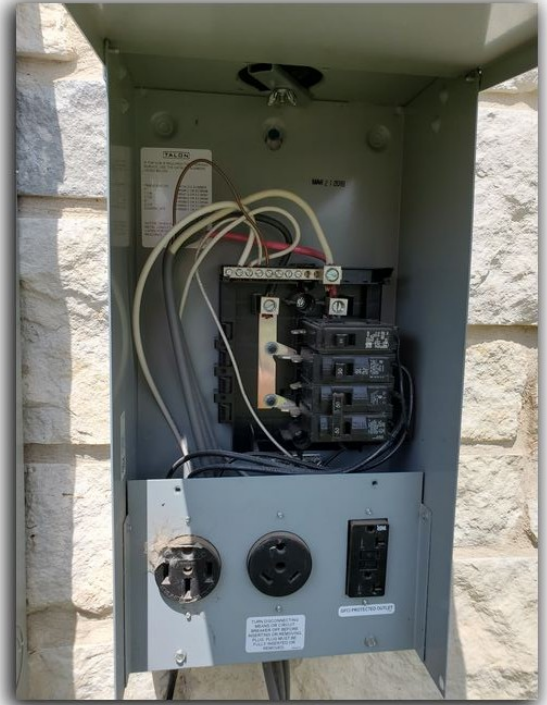
Picture of Sub Panel/s:

- *Panel is not labeled, missing labels, or labeling is illegible
- *Sealant is missing around exterior of panel enclosure
- ***Panel enclosure is not properly bonded**
- *Ground and neutral service wires are on same bus bar
- *Knockouts are missing in panel cover

Recommend consultation with Electrical contractor to address/repair deficiencies and further evaluate the electrical system

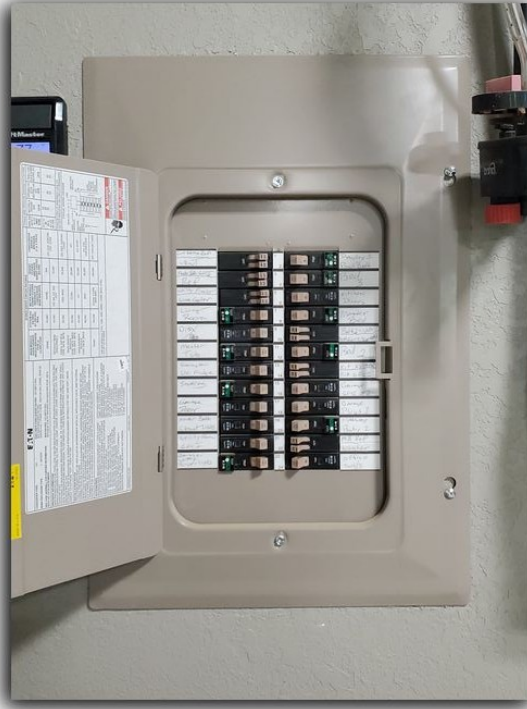
Picture of Sub Panel/s:

Note: AFCI DEVICES PRESENT BUT NOT TESTED --PROPERTY OCCUPIED

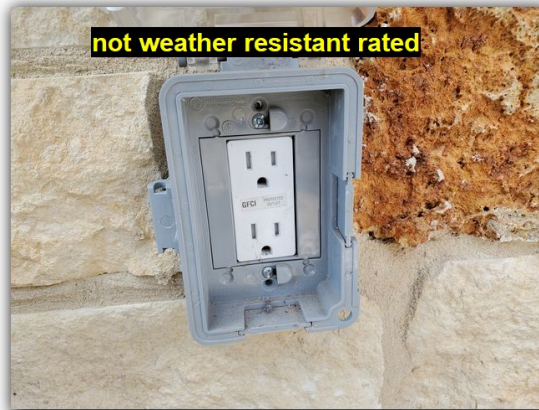
***Outlets at laundry area not GFCI or AFCI protected**

2014 NEC 210.8(A)(10) --GFCI protection is required for all 125V, 15A or 20A receptacle in the laundry areas

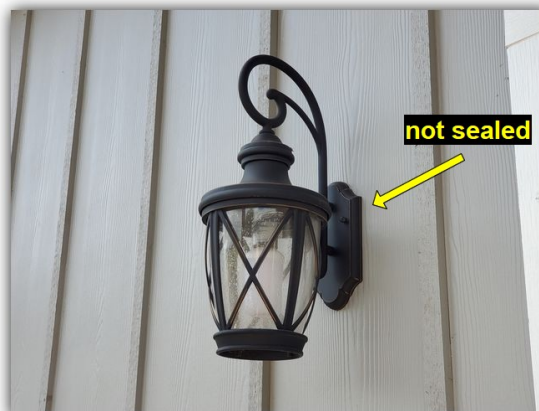
- *Ceiling fans not balanced at front left bedroom, rear porch, rear left bedroom, & master bedroom
- *Exterior fixtures not sealed or existing sealant is worn/deteriorated

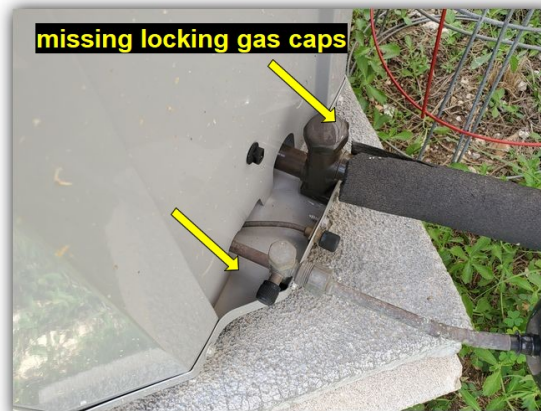
*Exterior condenser unit(s) missing locking gas caps.

***Condenser unit is under-fused.** Unit requires a minimum of 33.9-amps for proper operation. Breaker in main panel is only 30-amps

*Mini-split condenser unit is not level -- unit is leaning

Recommend consultation with Electrical & HVAC contractors to address/repair deficiencies and perform general maintenance on system.

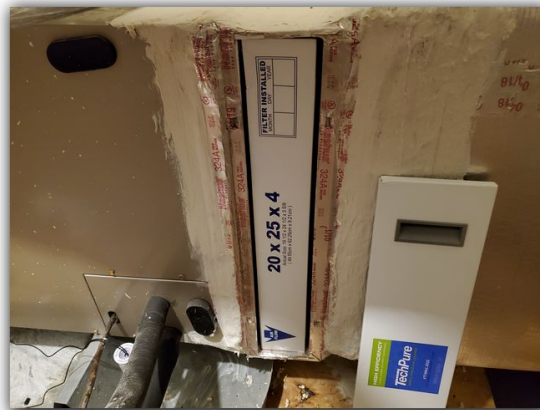
Note: Disconnected duct behind attic unit. Plenum has been sealed and does not appear to be leaking air. Recommend further evaluation of disconnected duct

*Return air filter(s) dirty-- needs replacement

Recommend consultation with HVAC contractor to address/repair deficiencies

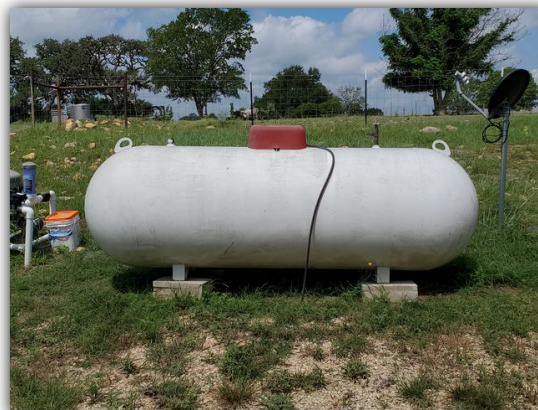
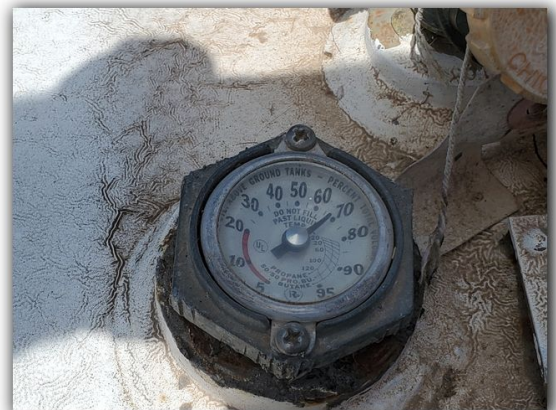
Note: Cannot verify gas distribution system is properly bonded to the electrical system.

Recommend consultation with Electrical contractor to verify proper bonding of the gas system

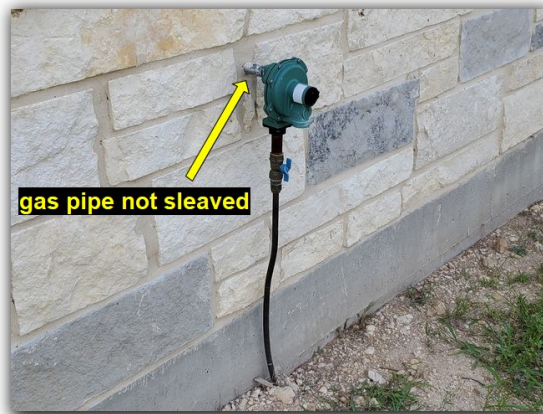
***Gas pipe extending thru the masonry wall is not sheathed in plastic to protect against corrosion**
IRC P2603.3 Protection against corrosion. Metallic piping, except for cast iron, ductile iron and galvanized steel, shall not be placed in direct contact with steel framing members, concrete or masonry. Where sheathing is used to prevent direct contact, the sheathing material thickness shall be not less than 0.008 inch (8 mil) (0.203 mm) and shall be made of plastic. Where sheathing protects piping that penetrates concrete or masonry walls or floors, the sheathing shall be installed in a manner that allows movement of the piping within the sheathing.

Recommend Consultation with Plumbing & Electrical Contractors to address/repair deficiencies

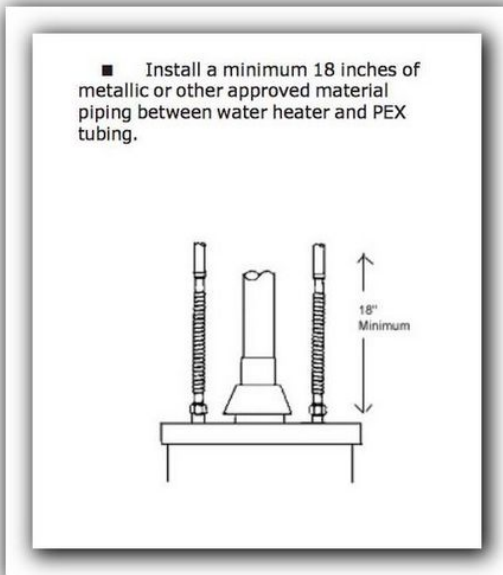
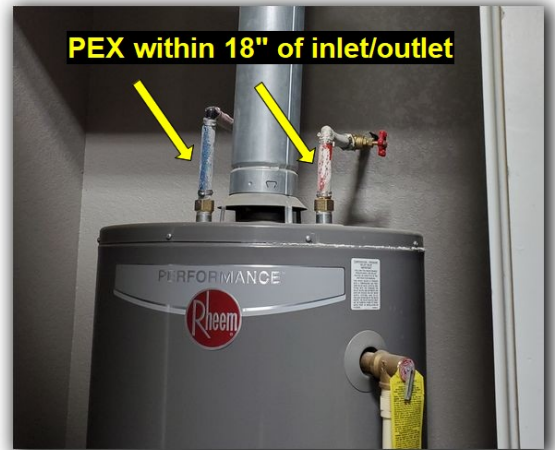
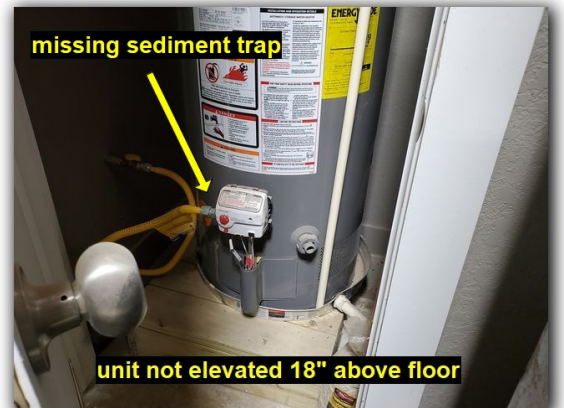
*T&P drain line terminates into the safety pan. Drain line termination is not above the flood rim of the safety pan-- terminates at the bottom of the pan

*PEX tubing installed too close to unit water supply inlet & outlet. PEX tubing must be a minimum of 18" from the unit inlet and outlet connections

Recommend Consultation with Plumbing Contractor to address/repair deficiencies

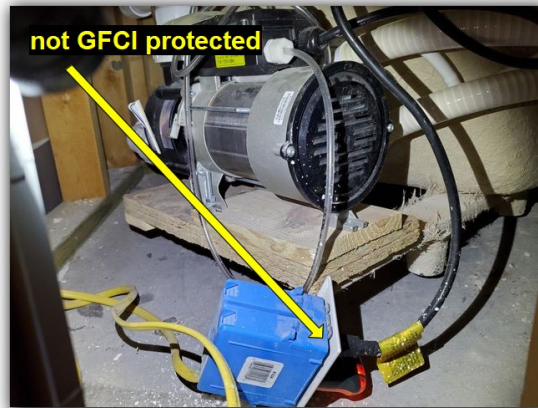
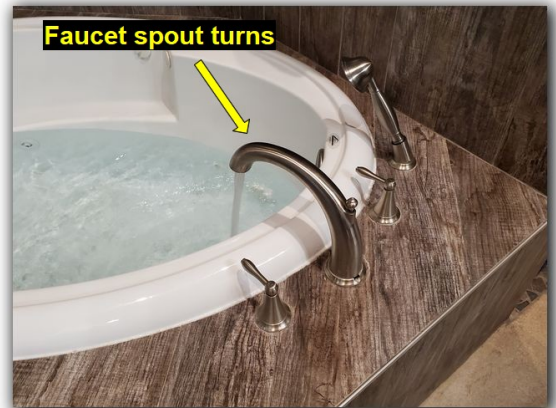
***Pump/motor is not GFCI protected. This is required by NEC code
Circuit breaker for Spa tub is an AFCI protection breaker, not a GFCI breaker**

Tub spout moves/turns -- not properly secured to tub

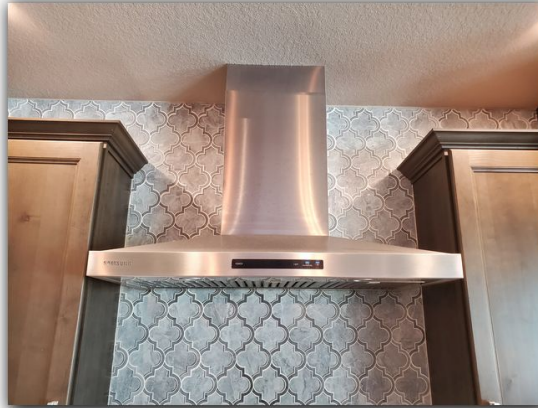
***Unit has flexible (corrugated) vent pipe installed in the attic space.** Minimum 6" diameter solid/smooth walled vent pipe is required to be used as flex-pipe is brittle and can trap/hold grease

Recommend installation of smooth-walled vent pipe

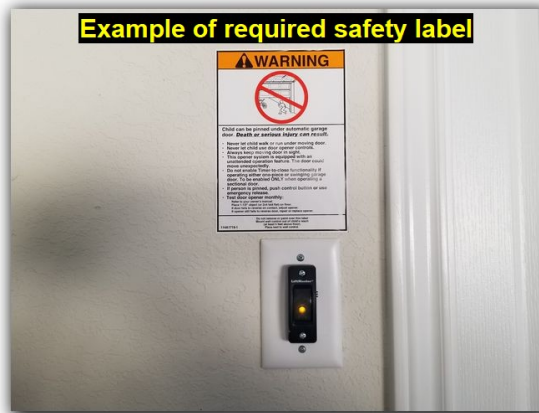
Note: Units were side-of-door mounted and did not have safety release mechanisms present.

*Required Warning/Safety label(s) missing at Tension spring and/or Opener operation button(s)

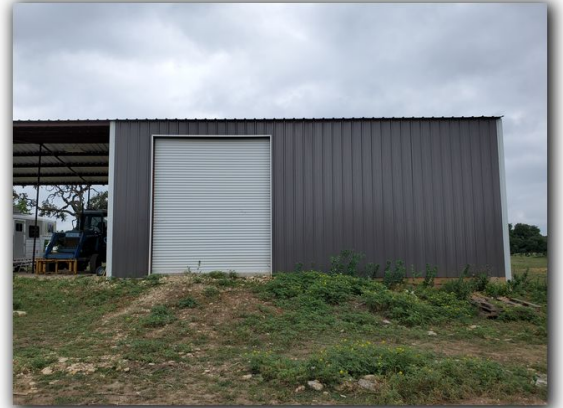
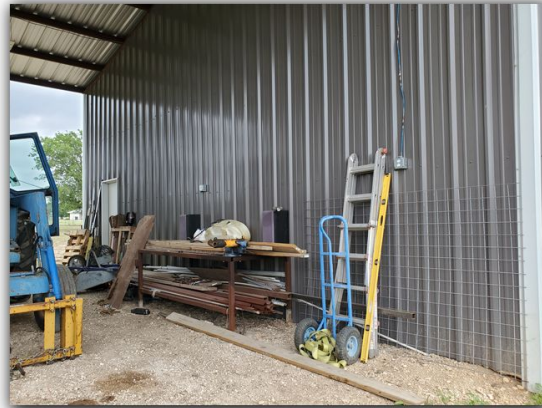
- *Electrical Panel is not labeled
- *Panel enclosure is not bonded -- missing bonding screw or strap
- *Bushings missing where wires pass thru panel enclosure
- *Lack of anti-oxidant grease on aluminum conductor terminals

- *All outlets at Workshop are not GFCI protected. This is required per NEC code**
- *Exterior outlets are missing weather-proof covers**

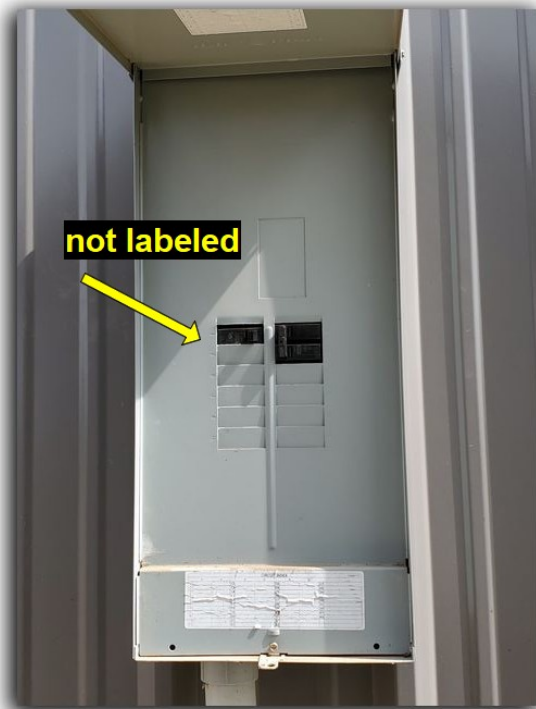
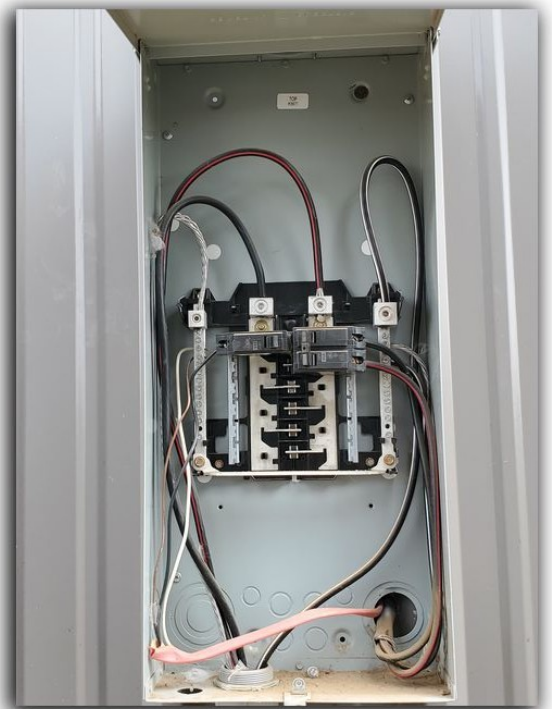
*RV outlet panel is loose on the front wall of the structure

***All outlets in stable are not GFCI protected. This is required per NEC code**

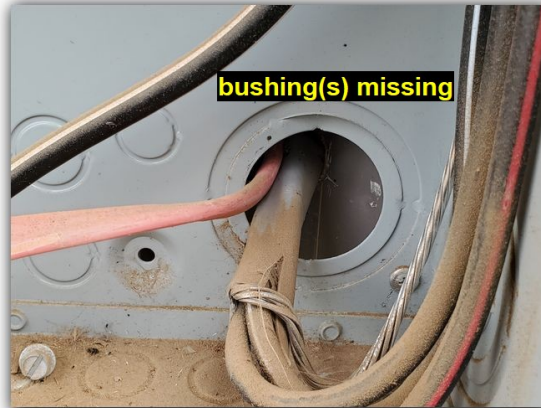
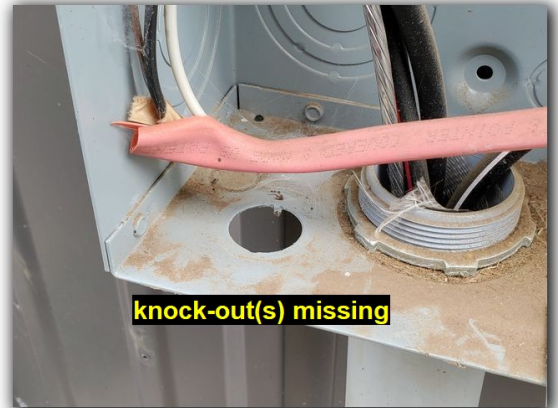
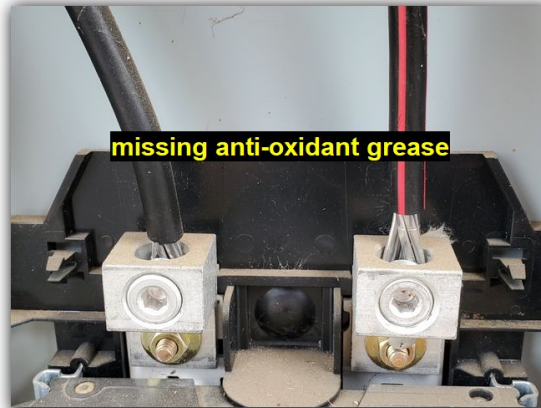
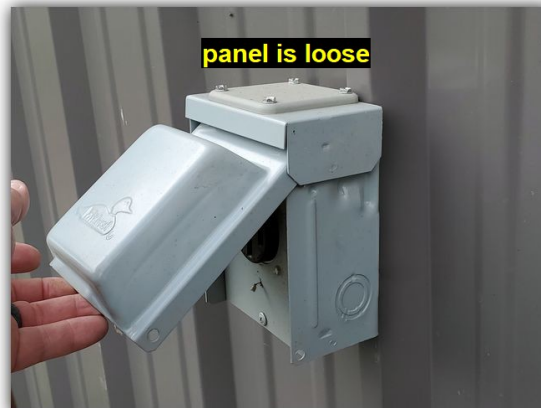
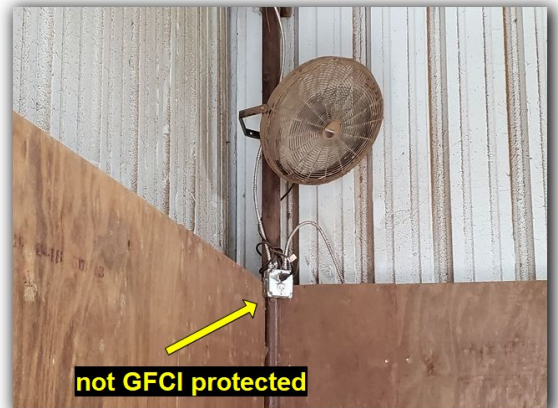
*Panel enclosure is not bonded -- missing bonding screw or strap

*Bushings missing where wires pass thru panel enclosure

*Knock-outs missing in panel enclosure

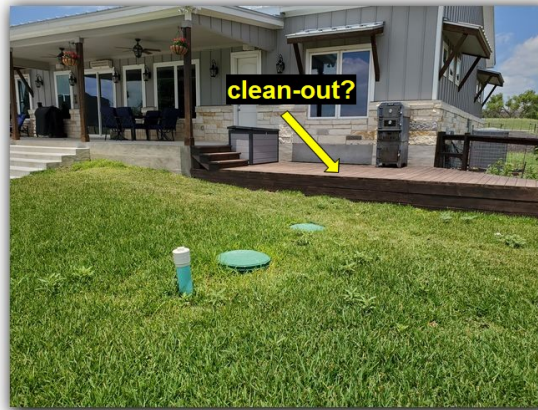
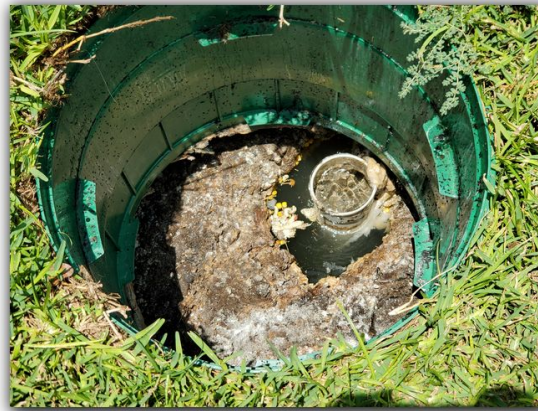
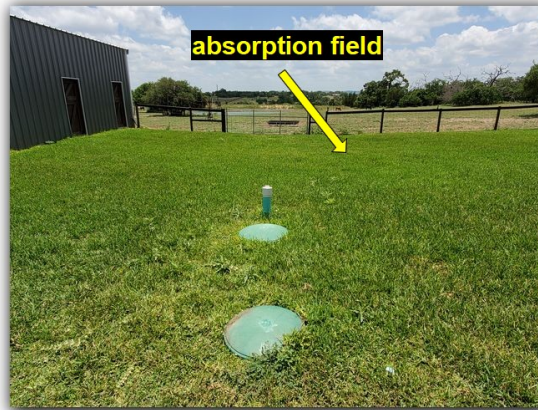
*Main clean-out is not observable or accessible under the rear deck

***Tank inlet baffle is clogged with solids. Recommend cleaning/clearing the inlet baffle**
