# “Serenity Cabin”

**337 Sand Creek Rd., Beulah, WY 82712**  
**House Notes and Improvements<sup>1</sup>**

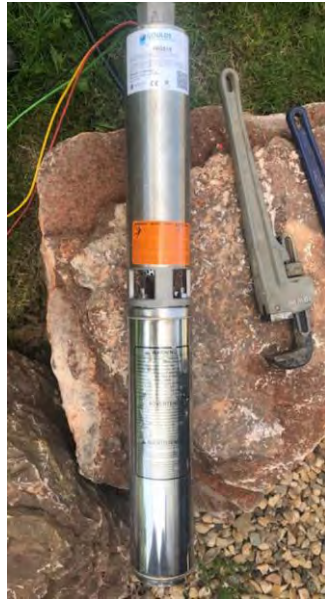
(2) 1½ hp Franklin 3-wire w/ ground motor, as follows:

(3) Pressure to the house and the irrigation system is adjustable and constant.

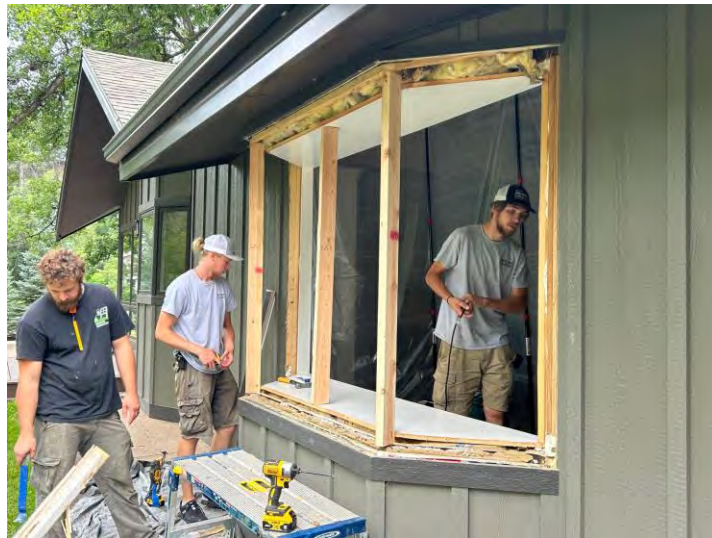
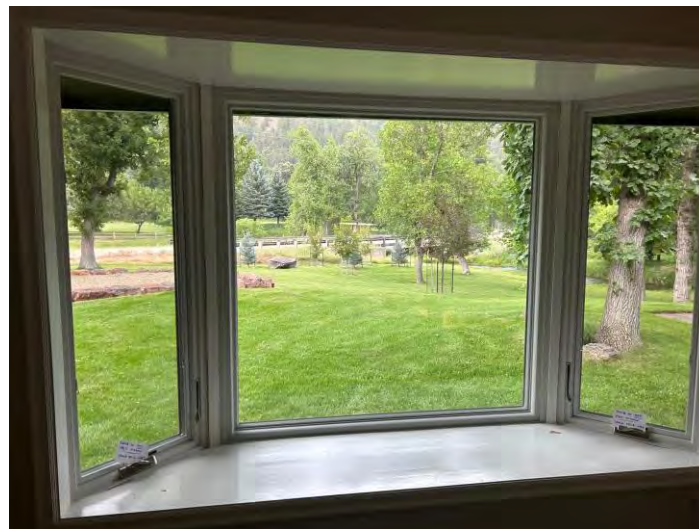
1. Replaced kitchen disposal (InSinkerator), Tommy Trandahl, Feb. 2023, ≈ \$900.
2. Painting (various touch ups and repaint, including exterior window and door frames)
3. Installed emergency shut-off valves for attached garage hot and cold-water spigots, used for the pressure washer.
4. The pipes on the bottom of the pressure tank in the well pit, under the pressure valve, was replaced in early October; there was a pin-sized hole under the valve that was leaking.
5. In August 2023, we replaced living room and master bedroom bay windows with high-end Andersen Windows (≈\$32,800). Andersen windows have their own crew, so they did the installation.

- a) Identifying information for the new bay windows, including energy performance ratings, is as follows:
