Sam Preuss	9-16-2022
<i>Name of Client</i>	<i>Date of Inspection</i>
550 Co Rd 221, Cameron, TX 76520	
<i>Address of Inspected Property</i>	
Gary Mohel	TREC #4211
<i>Name of Inspector</i>	<i>TREC License #</i>
<i>Name of Sponsor (if applicable)</i>	<i>TREC License #</i>

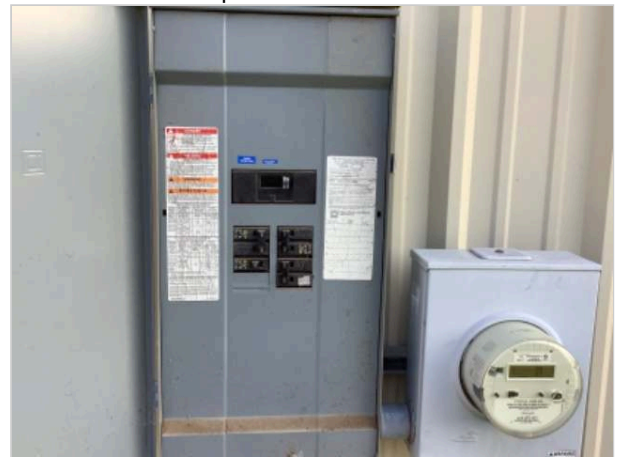
Garage wall entrance panel

*Deficiencies:*  
Utility pole entrance panel: Breaker knocks were open in the panel. There was a 30 amp breaker in the panel with #12 wire. Number 12 wire is normally served by a 20 amp breaker although there are exceptions. There were multiple wires inserted into the same hole on the neutral bus bar in the panel, a common practice but not per NEC standards. Neutral wires should be in a hole by themselves. Two securing screws were missing for the inside cover of the entrance panel on the garage wall. One or more white sheathed wires were not marked as hot at connections to breakers in both entrance panels and in both sub panels, which today's standard requires. A breaker knockout was open in the garage sub panel.

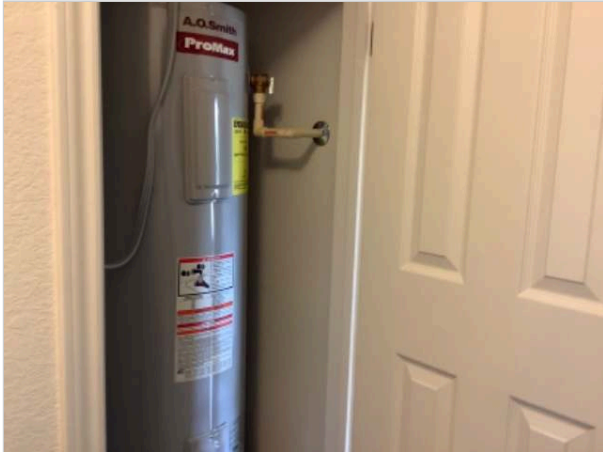
Hall water heater

The water heaters did not have expansion tanks which is required per today's standards when a water pressure reducing valve is on the water line. There was corrosion on the lower tank of the water heater located in the hall closet, apparently from a leak at the lower element. There was not a leak observed at the time of the inspection. The garage water heater lower element was not 18" above the garage floor.
