This plot is based on an actual field survey performed by or under the direct supervision of Gerald Hart Wallingford, Registered Land Surveyor 6526 on September 12, 2022.

Countrytyme Land Specialists, LTD
 Township - Vinton County, Ohio
 Part of Section 15, Township 10 North, Range 18 West
 O.R. Vol. 179 Pg. 486
 P.N. 080035000
 Tract One - Orig. 40 Ac.
 P.N. 0800357000
 Tract Two - Orig. 66 Ac.
 P.N. 080035000
 Scale: 1" = 200'
 September 12, 2022

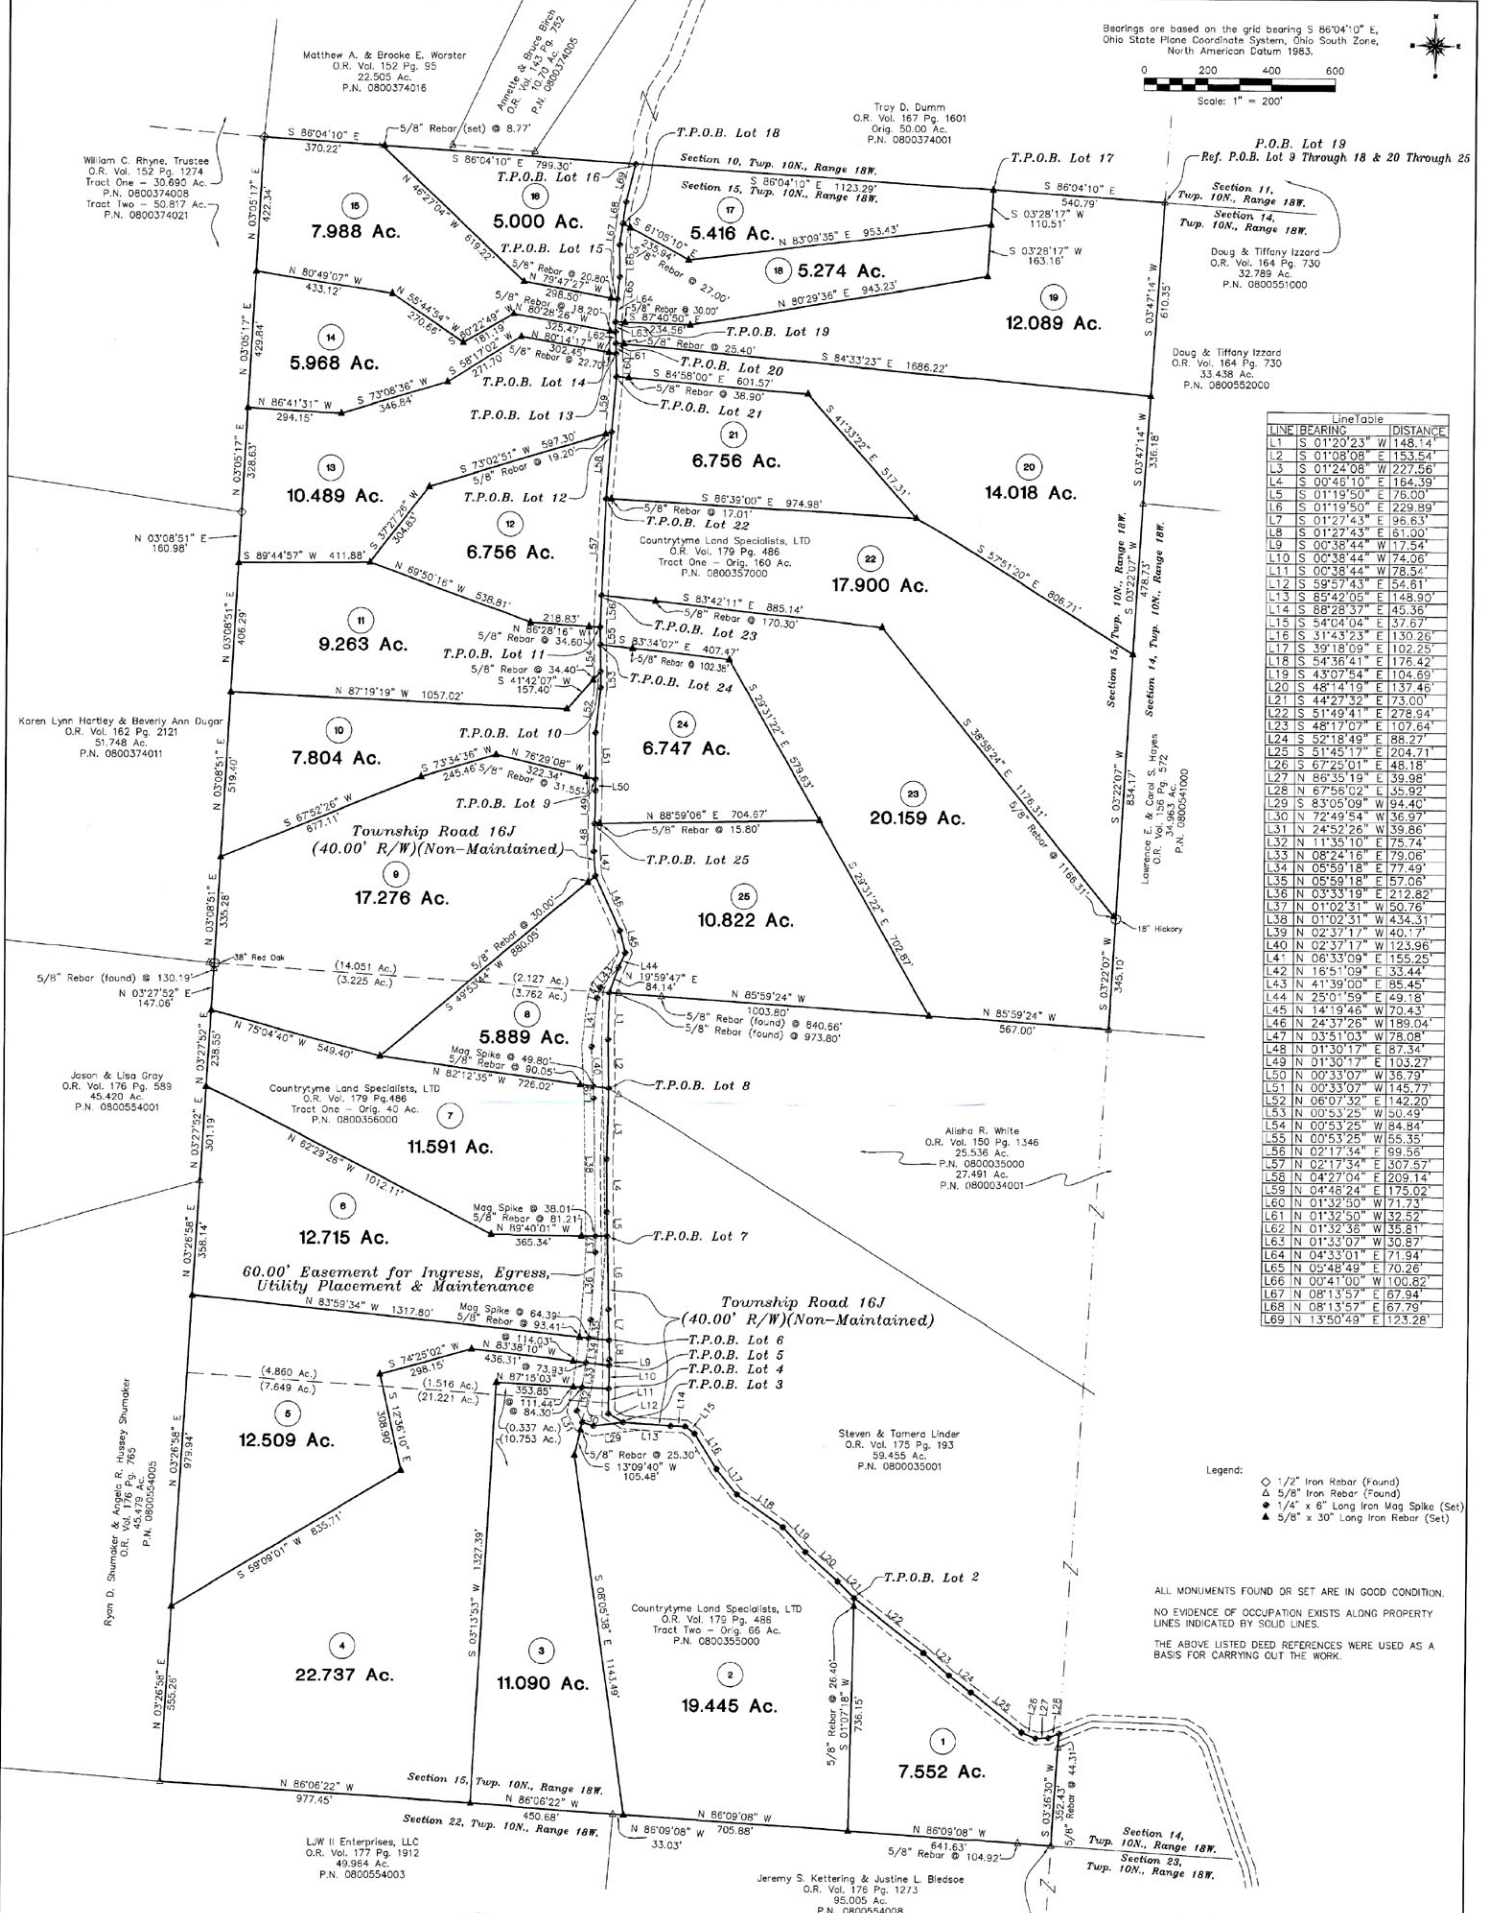
Bearings are based on the grid bearing S 86°04'10" E, Ohio State Plane Coordinate System, Ohio South Zone, North American Datum 1983.

ALL MONUMENTS FOUND OR SET ARE IN GOOD CONDITION.
 NO EVIDENCE OF OCCUPATION EXISTS ALONG PROPERTY LINES INDICATED BY SOLID LINES.
 THE ABOVE LISTED DEED REFERENCES WERE USED AS A BASIS FOR CARRYING OUT THE WORK.
