**NATIONAL REGISTER OF HISTORIC PLACES  
REGISTRATION FORM**

historic name LINDEN

Linden  
Essex County, Virginia

**SUMMARY DESCRIPTION**

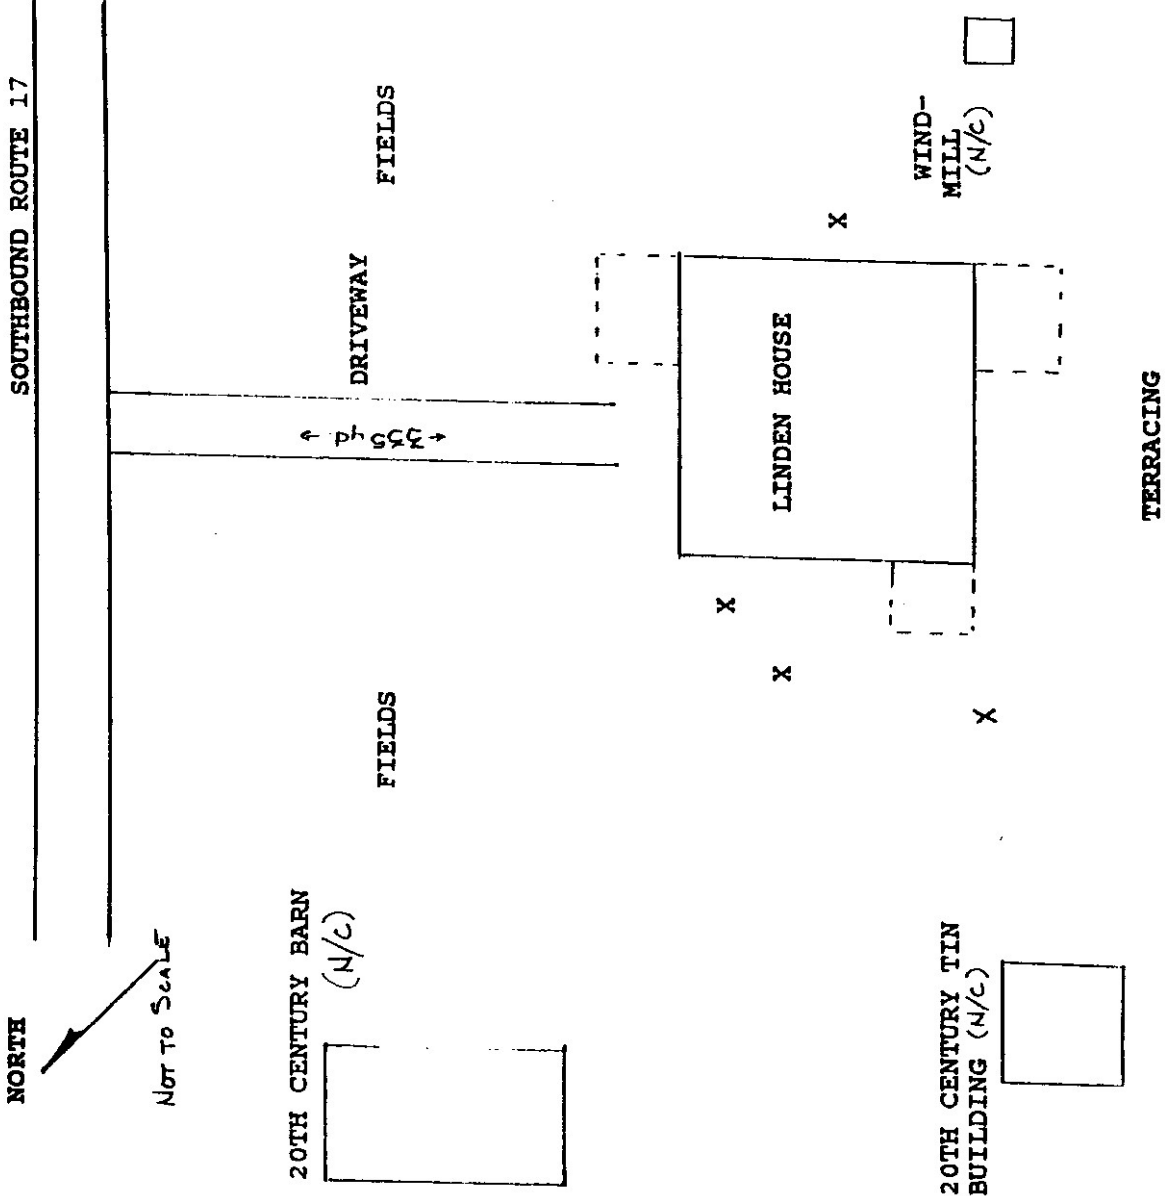
**SITE PLAN FOR LINDEN PLANTATION**

-----  
**X=FOUNDATIONS OF EARLY OUTBUILDINGS**

Just north of the house is the buried foundation of a small outbuilding, probably dating to the same period as the house. A brick foundation has been revealed about five yards west of the house. Because of its size and evidence of charring, it is thought to have been a smokehouse. Approximately fifteen yards from the northwest side of the house is what may be a stone foundation.

Three early twentieth-century resources stand at a distance from the house. About 130 yards north of the house is a 40'- 5" X 20'- 5" wooden barn. It is supported on piers of stone and wood. The barn is approximately eighteen feet tall at the peak and has a corrugated tin roof. Forty yards west of the house is a two-story, wood-frame shed with wood pier underpinnings. Corrugated tin sheets are bolted together to form the walls. The shed is 18'x 18' and has five six-over-six double-hung sash windows and a door on the second story. The first story has no partitions and may have been used for storage. The second story is divided into three rooms and there is evidence of a stove at the junction of the three rooms, which is located directly under a chimney. Approximately thirty-eight yards southeast of the house is a dilapidated metal windmill that stands about forty-five feet high.

An early graveyard without markers lies to the rear of the house. There is also evidence of landscaping and terracing to the rear of the house. These landforms begin approximately twenty-five yards southwest of the house and are about seventy feet wide. There are three clearly discernable terraces or steps to the formation, each drops about one and a half feet lower and extends about four feet outward. They have been partially destroyed in areas and are overgrown with weeds and grass.
