60 Liberty Ln  
Highland, IL 62249

Prepared For: Amy Cadagin

Inspected On Thu, Feb 6, 2025 at 1:00 PM

Metro East Home Inspection LLC

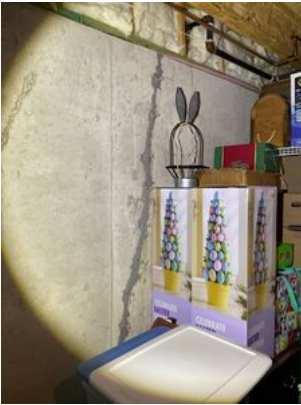
Prior professional repairs were noted at the foundation wall. It is recommended consulting the current owners for the existence of transferable warranties.

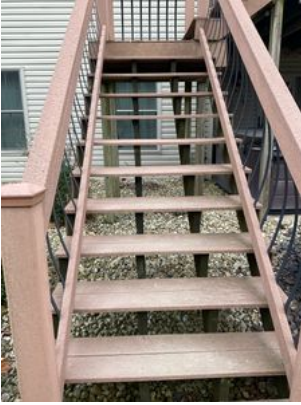
The steps serving the deck have open risers and could present as unsafe. The openings in the risers are large enough for a child to fall through. It is recommended that this be corrected for improved safety.

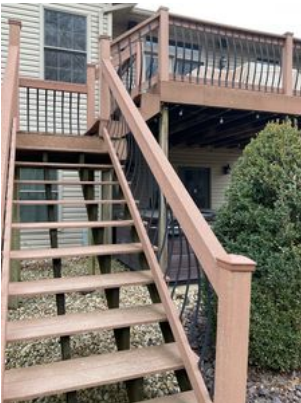
Loose railings at the rear deck should be better secured.

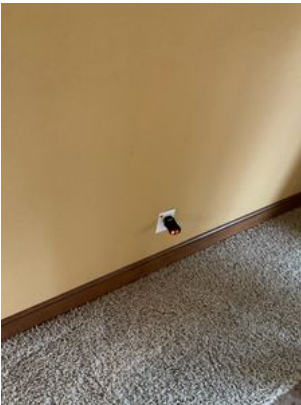
Loose outlets in the basement family room and bedrooms should be better secured.

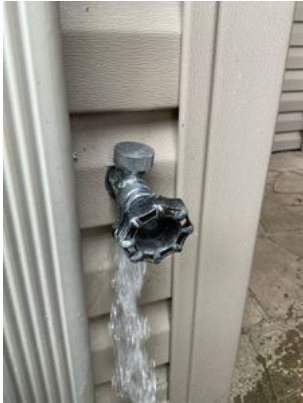
The hose bib at the rear of the home leaks from the anti-syphon cap when operated.

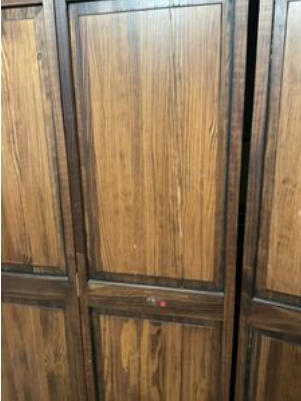
Damage was noted to the closet door in the front left bedroom. This damage does not affect the function of the door.

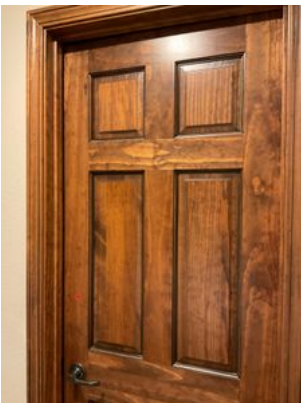
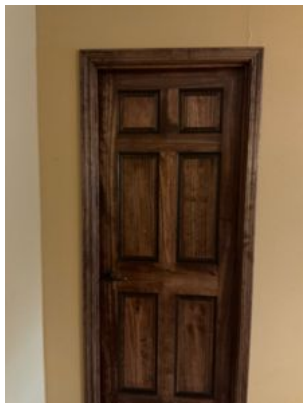
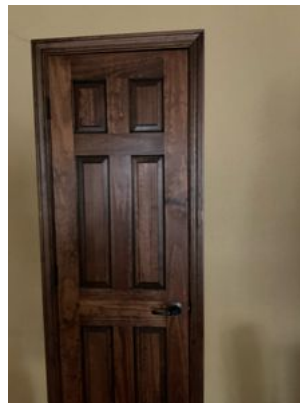
**Comment 39**

Doors serving the rear left basement bedroom closet, water shut off closet and front unfinished area should be trimmed or adjusted as necessary to work properly.

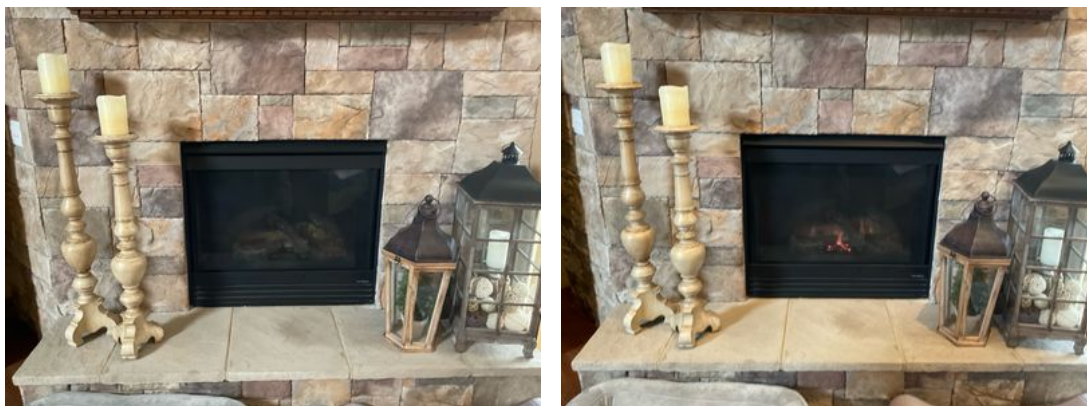
### Fireplace Photo

On the whole, the fireplace and its components are in above average condition.
